# The Landmark Trust

## CAUSEWAY HOUSE

### History Album

**Architect: Stewart Tod and Partners, Edinburgh**

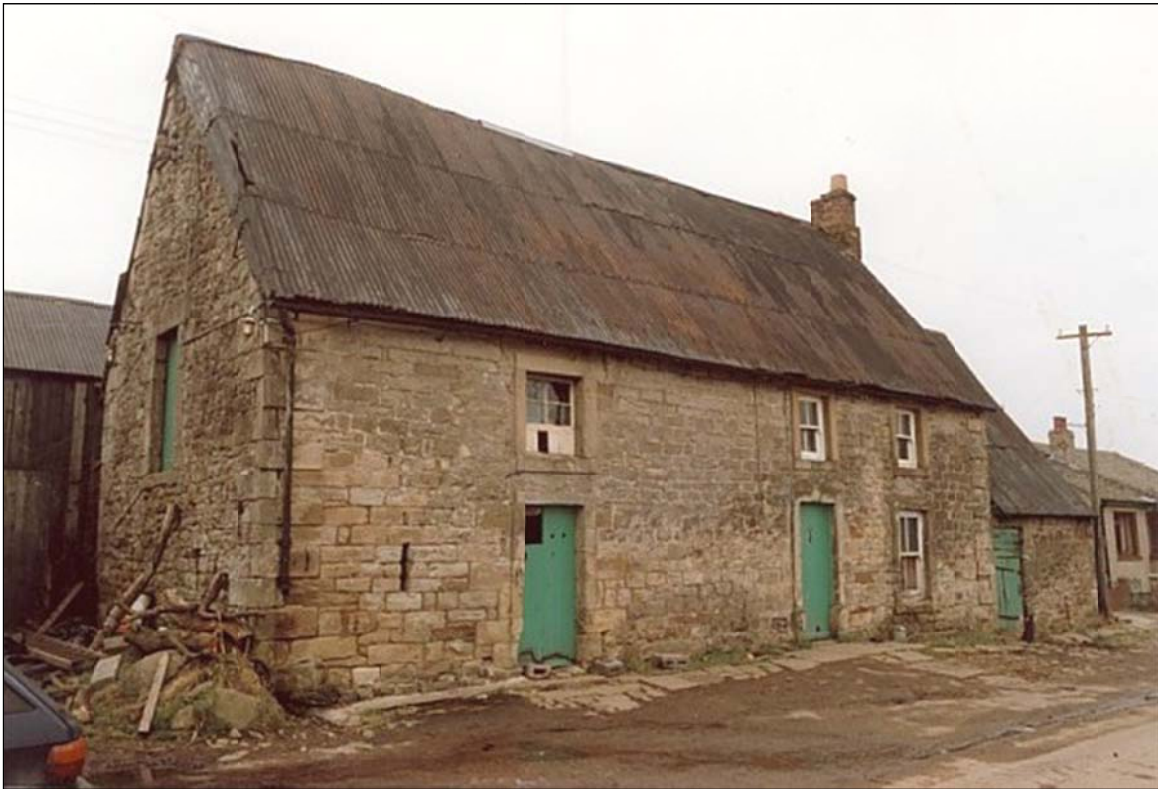
**Causeway House in 1988, with its thatched roof covered with corrugated iron.**

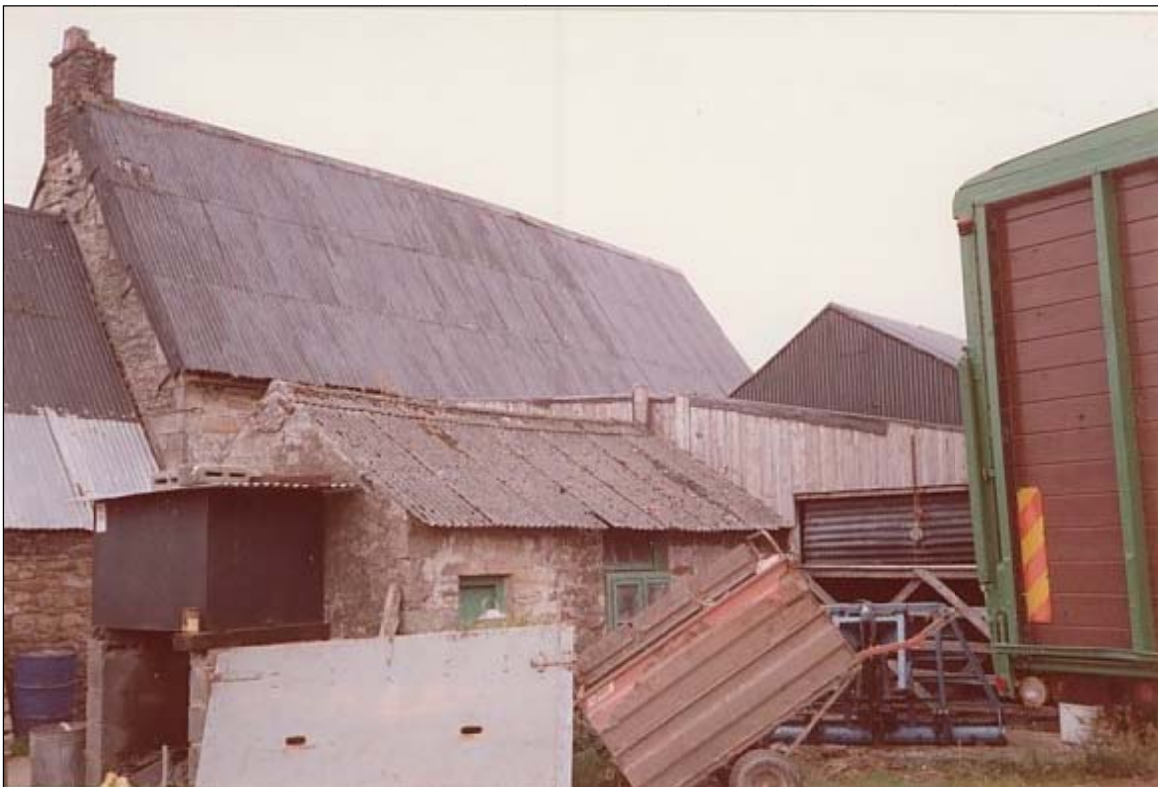
**The north side showing the dairy as it was and several sheds.**

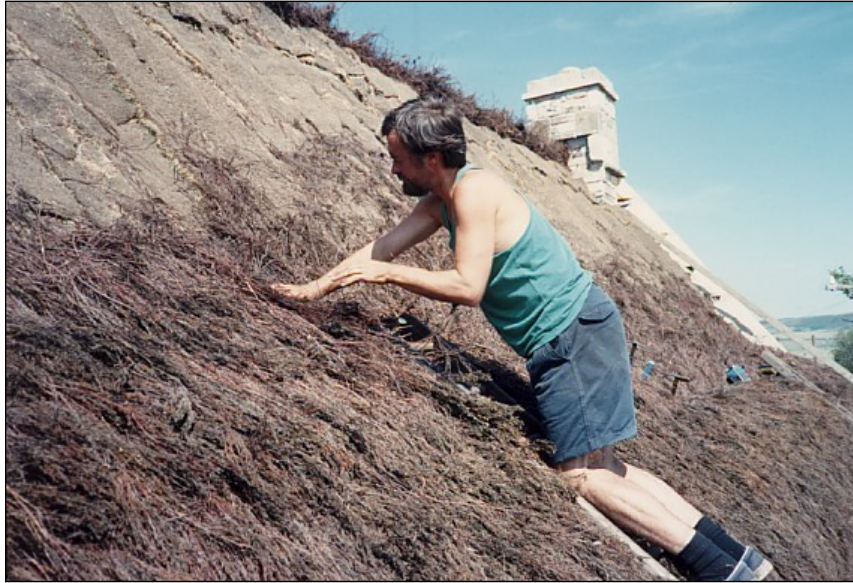
The turf under the thatch is laid green side down.

the rafters. Heather is a material which is laid 'upside down' compared to other materials in that the root end is placed on the inside against the turf.

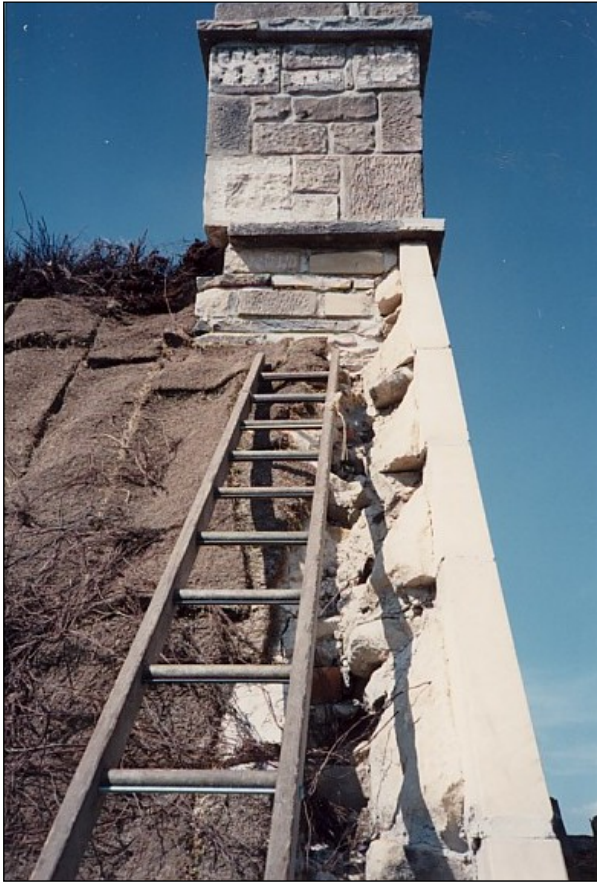
The thatch was 16-24" thick.

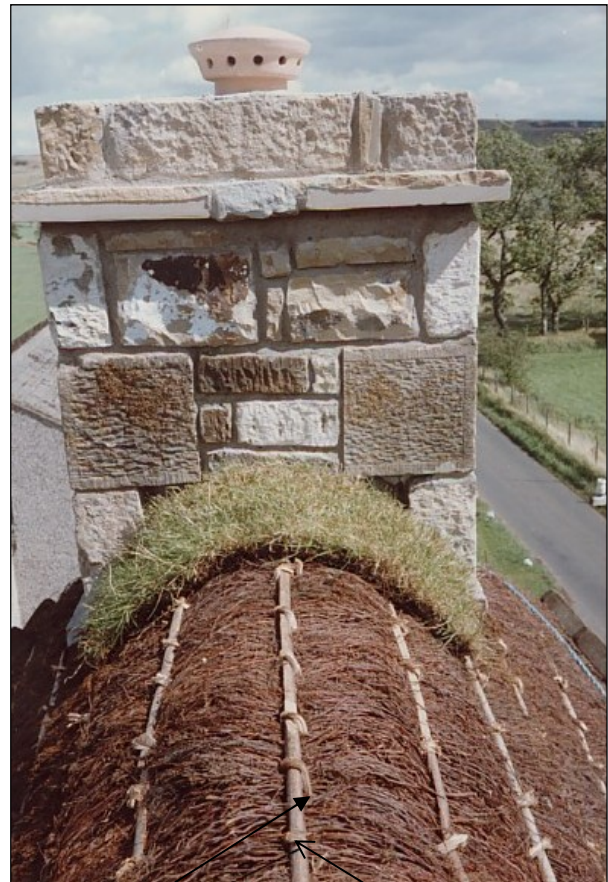
spar

ligger

The ridge was dressed with a layer of turf green side up.

Side pins

The ridge, which needs the longest lengths of heather, was held in place with long hazel and willow spars used like giant hair-pins. After clipping the rough ends, it was finally dressed with a layer of turf, green side up, which is a traditional way of finishing Northumbrian roofs. Finally the thatch was given a protective layer of black mesh that at first was secured by spars positioned in the hollows that form on heather roofs. Unfortunately, this made the roof look like a giant buttoned sofa and so the spars were all moved to the 'hills.' This looked much better and the result was a roof that lasted some 20 years. In 2008, this whole process was repeated, still using heather, but this time done by Stephen Letch who looks after several other Landmark thatched buildings in East Anglia. He specialises in long-straw thatching, which is a less commonly-used form of thatching these days, but not dissimilar to how a heather thatch roof is laid.

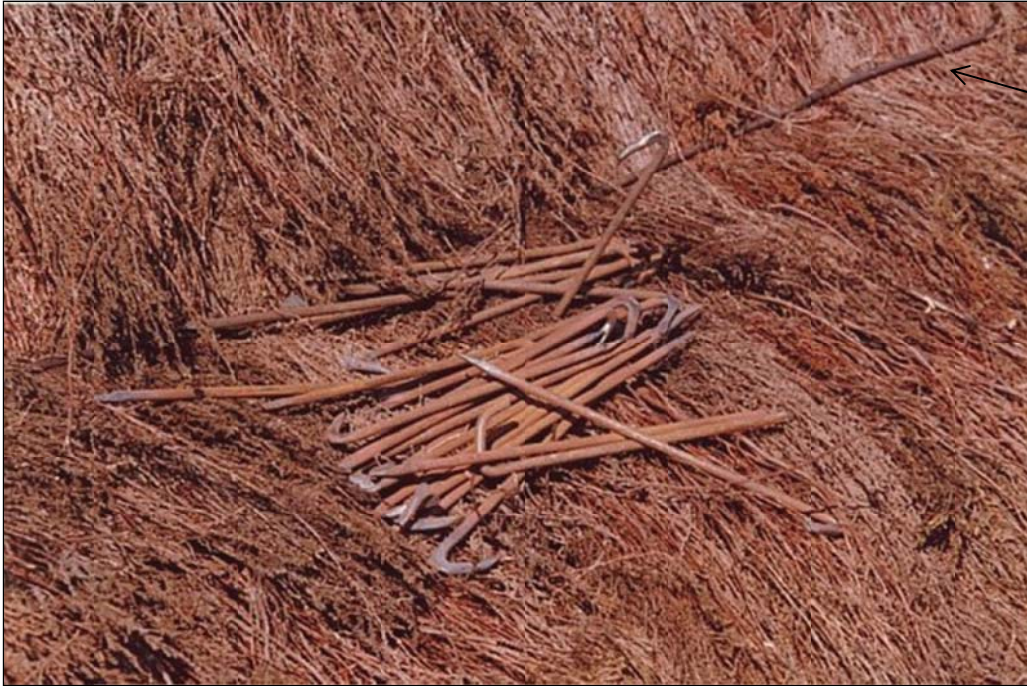
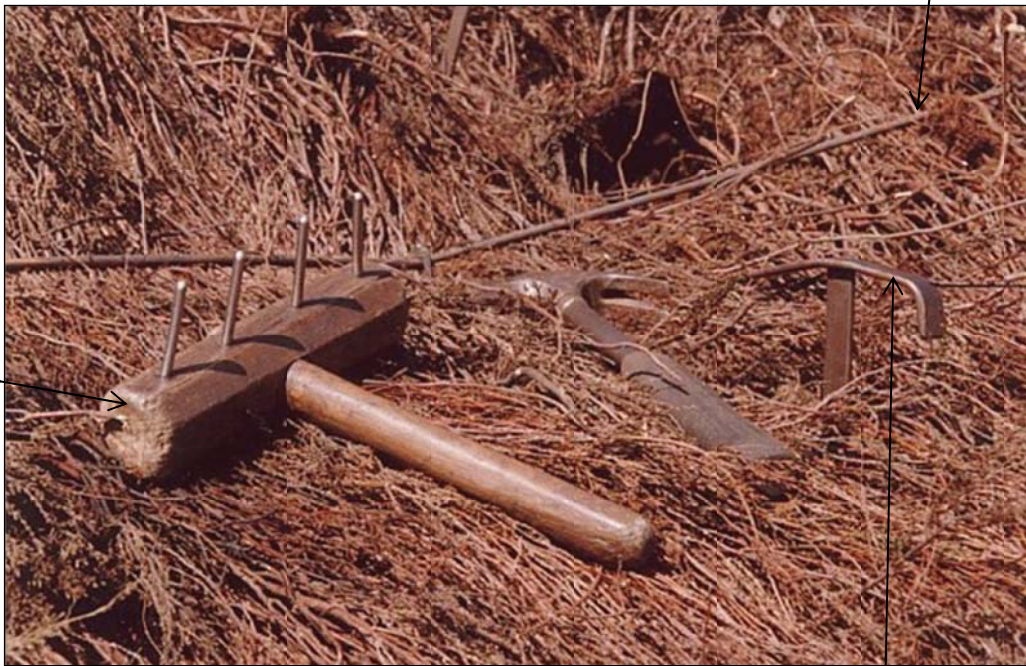
Tools

sway

rake

Side pin

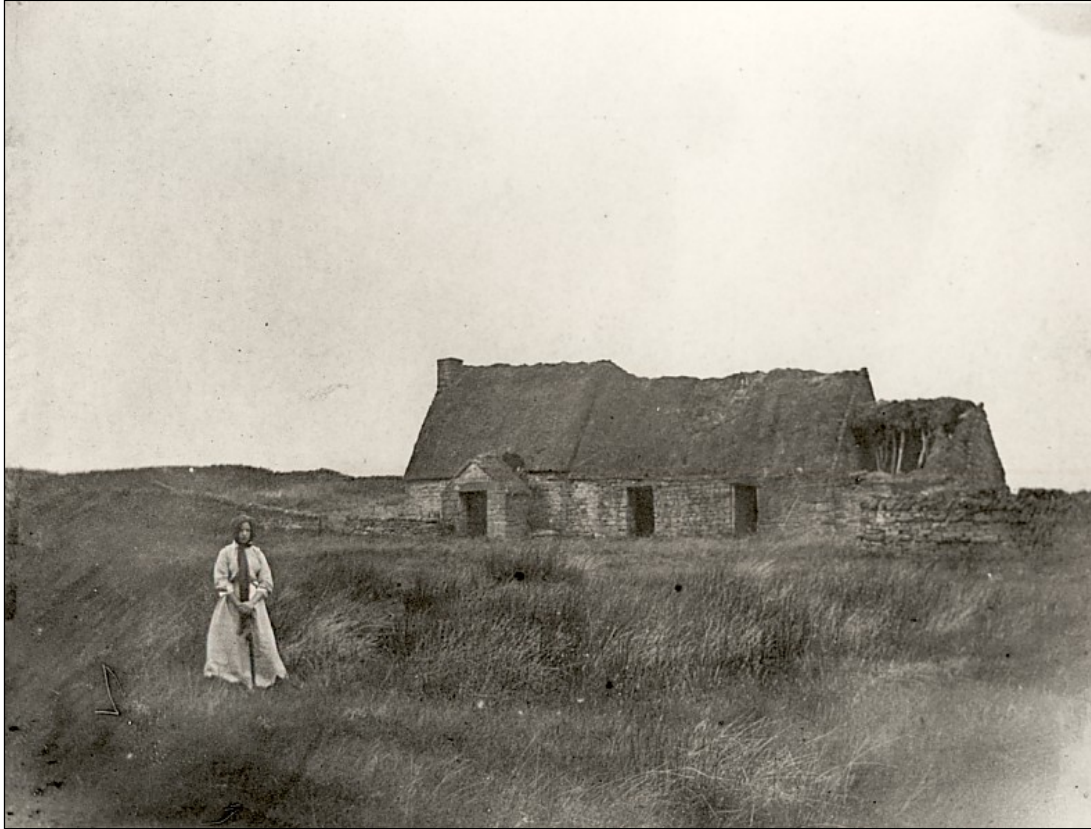
**What almost happened to Causeway House: the gradual deterioration of Cragend, a heather-thatched steading not far away, recorded over some fifty or sixty years**
