## MORPETH CASTLE History Album

**Researched and written by Clayre Percy, 1991**

THE GATEHOUSE OF MORPETH CASTLE, NORTHUMBERLAND

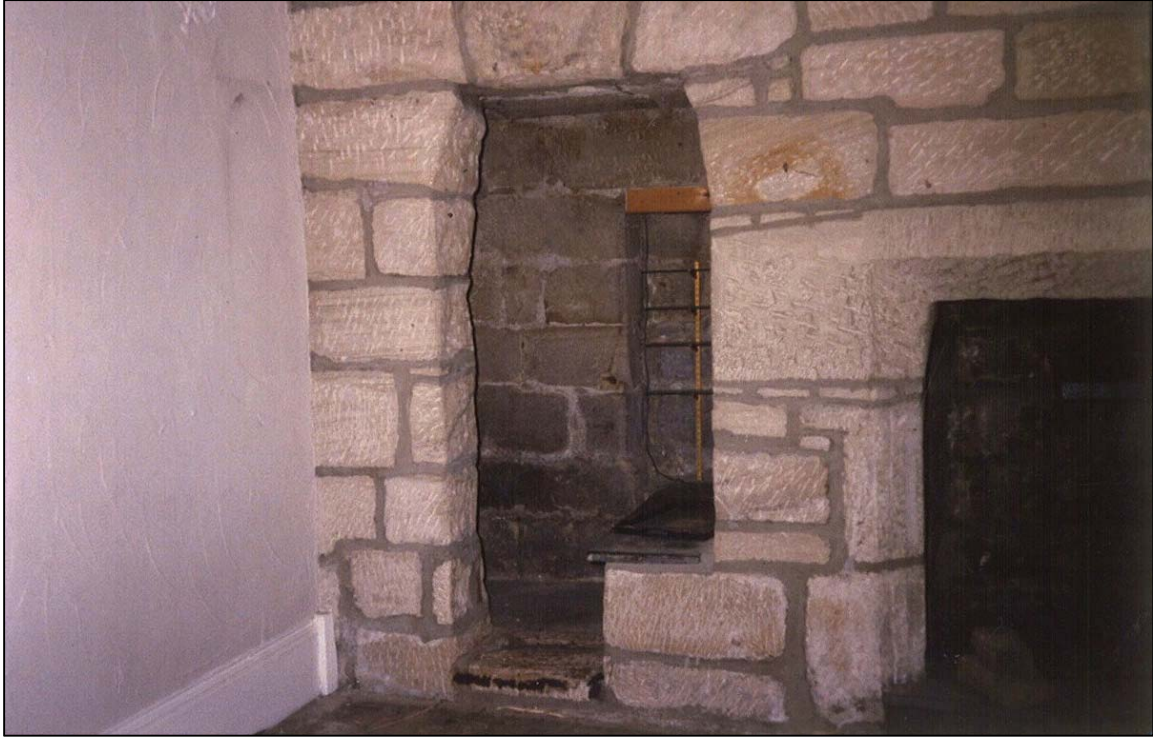
Opening made in 1960s into garderobe on north end of first floor, now built up.

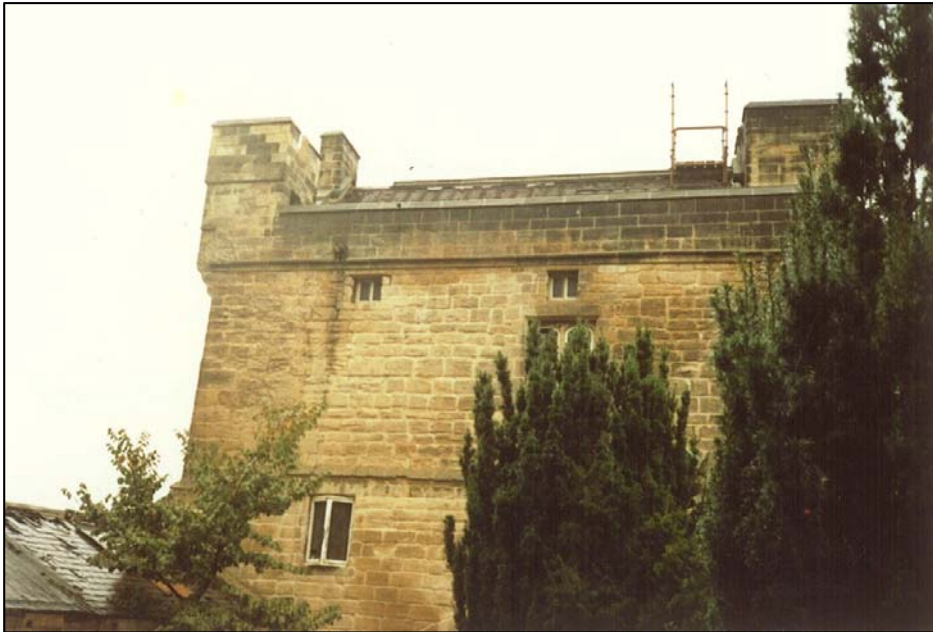
The 17<sup>th</sup> century windows as they must have looked. Here they are mock-ups made of cardboard.

The two small 17<sup>th</sup>-century windows were partially unblocked and repaired and the sky lights were renewed.

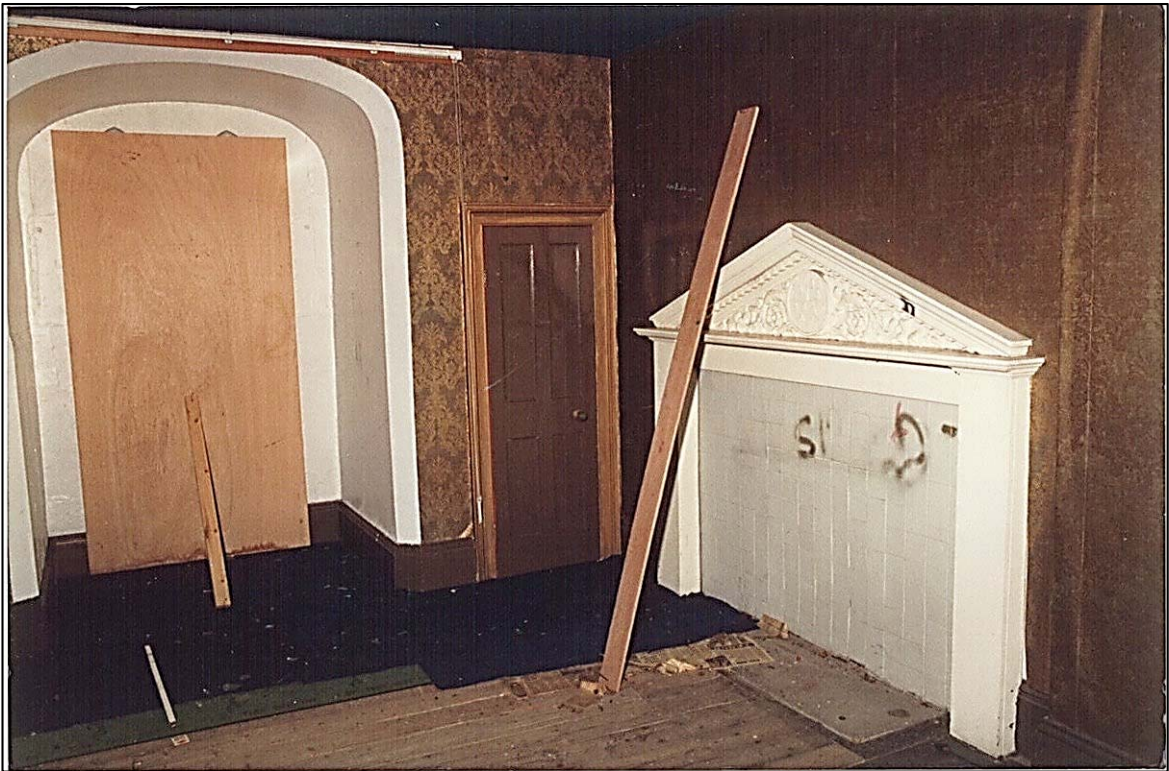
**First floor, kitchen end before restoration. The door led into a wall in the garderobe.**

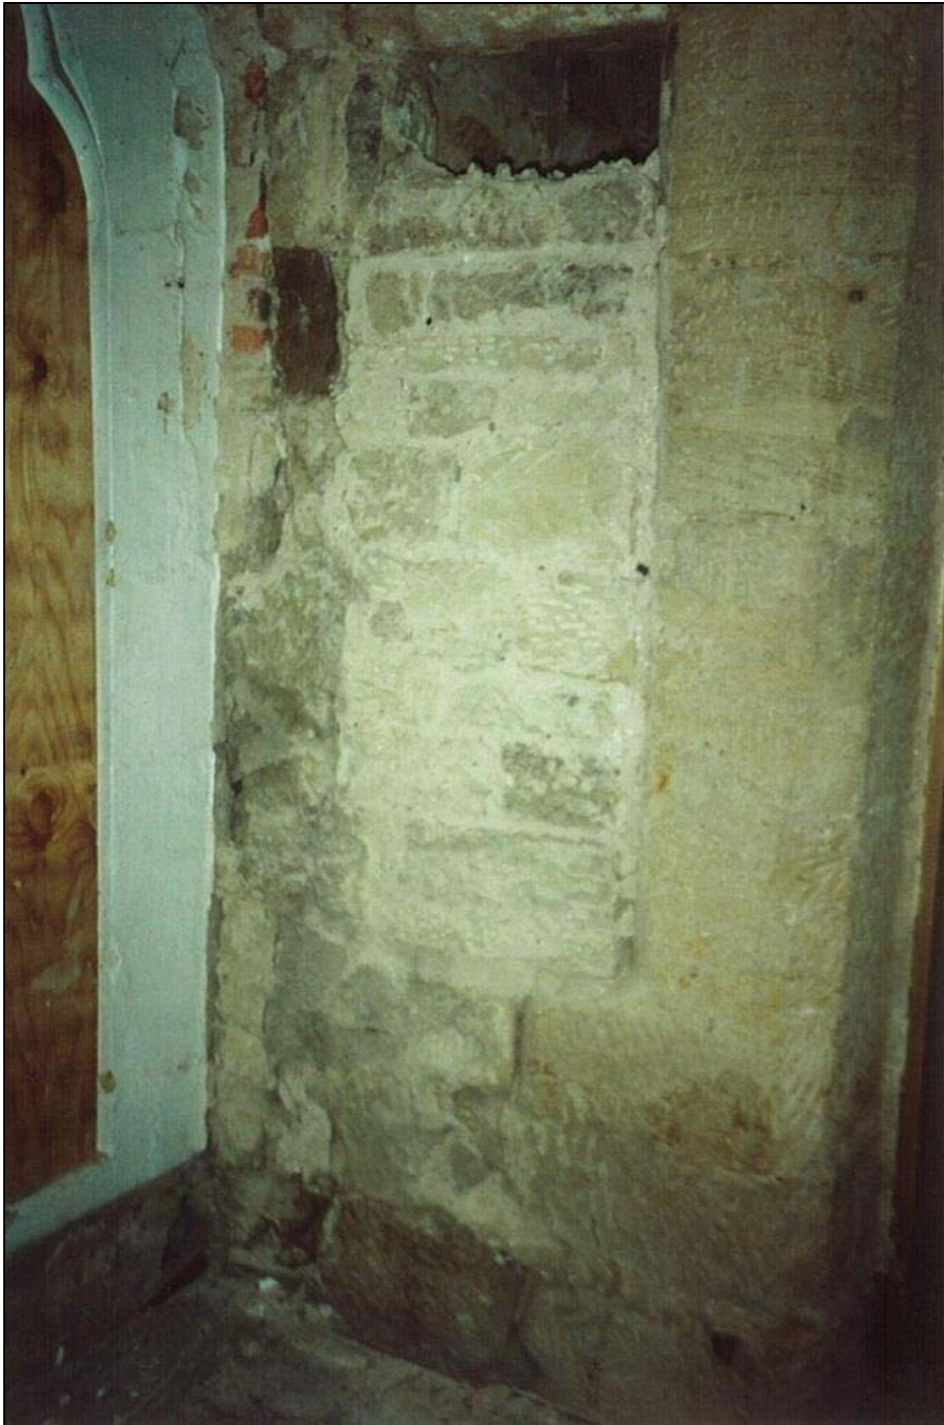
**Discovering the original garderobe in the kitchen, to the right of the window.**

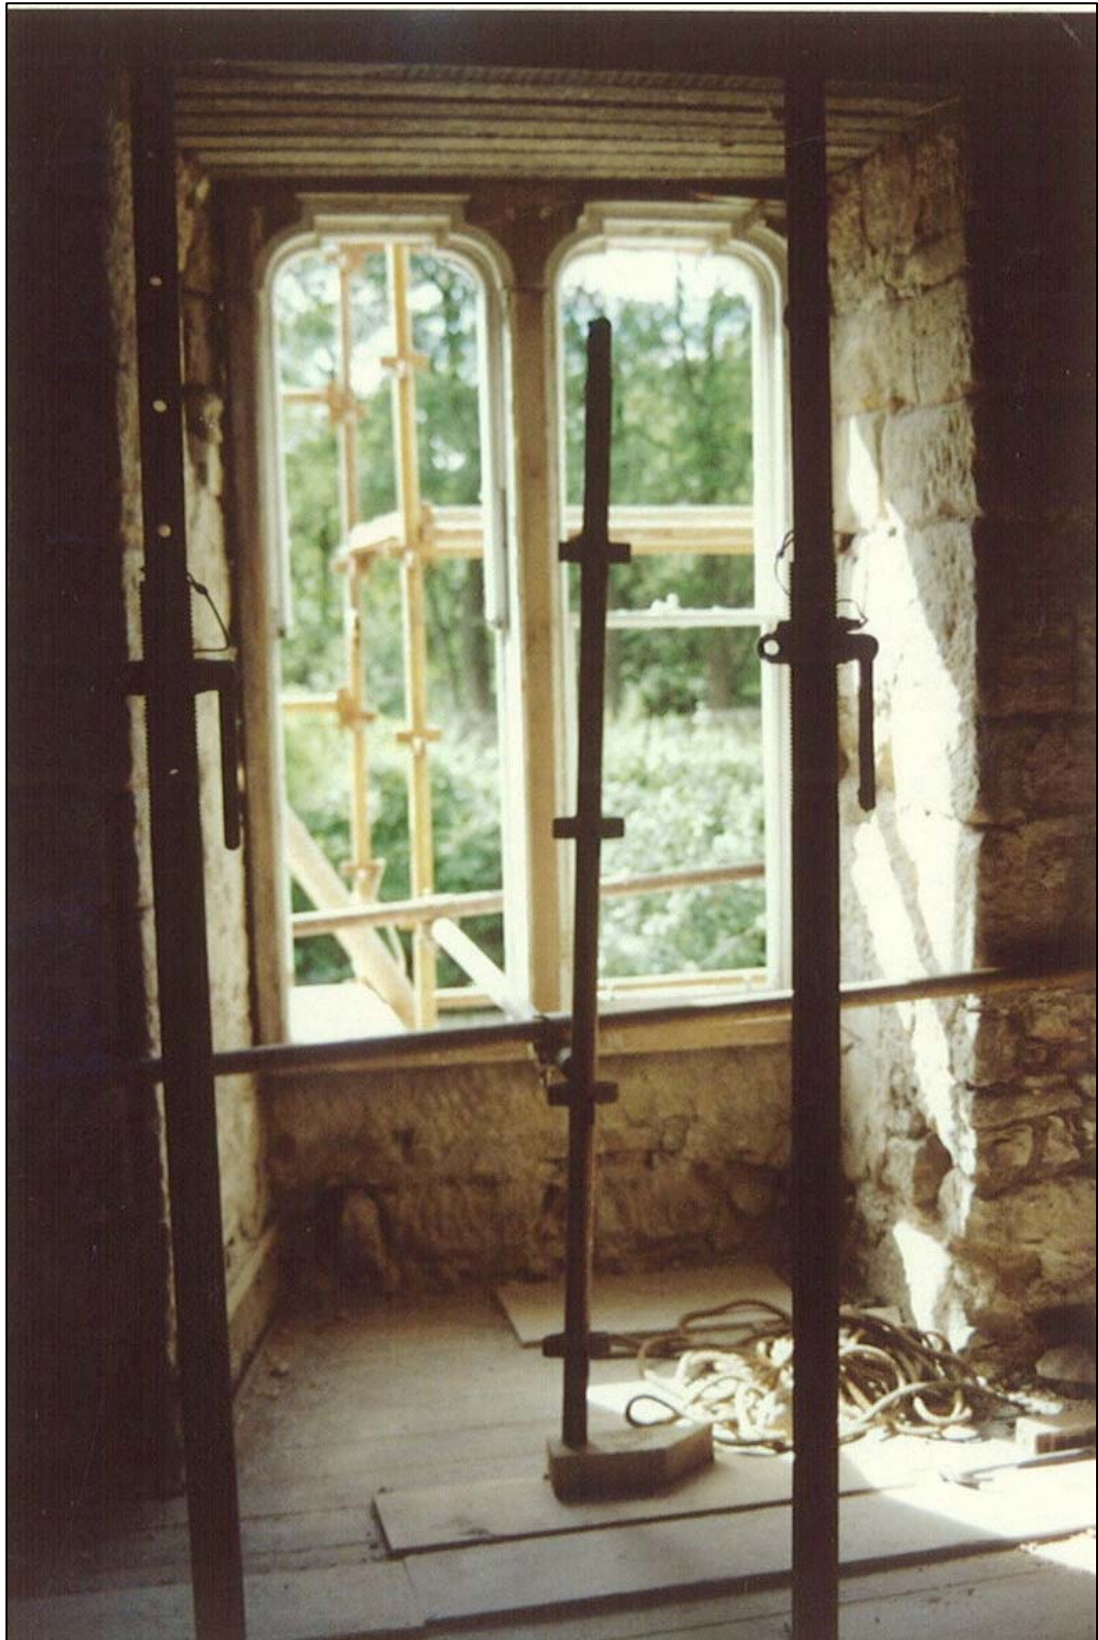
**Window onto the second floor passage. The level of the original floor is shown by gaps in the stone work.**

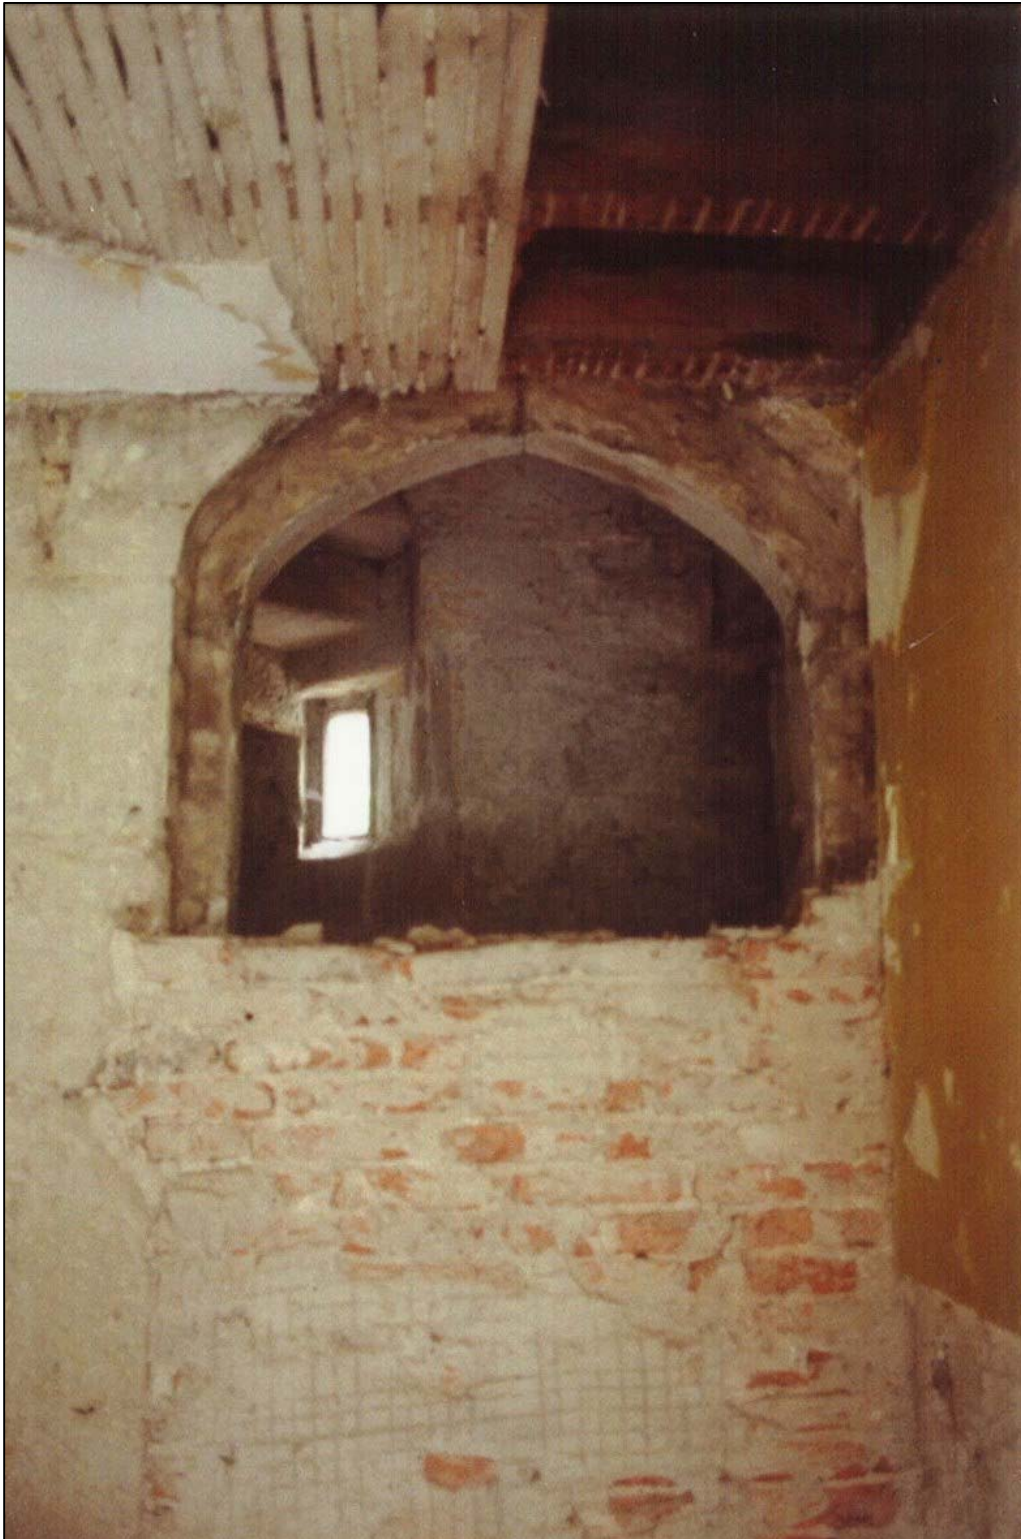
**Opening the original doorway from the spiral stairs to the second floor, December 1990.**

The central Victorian staircase was removed and the newel stair, which led only to the roof, was put back into commission. The medieval doorway leading from the stairs to the second floor was reopened. With the change of floor level, the threshold of the spiral stairs at the second floor was 18" higher than the level of the actual floor. Three steps now lead up to it. It was here that two shoes were discovered built into the threshold. Between the first and second floors the door leading out onto the walkway round the top of the curtain wall was replaced with a fixed door with a window, the curtain wall having crumbled, it lead out onto nothing. A new staircase was put in between the second and attic floors against the south wall, and the old one, against the east wall was removed.

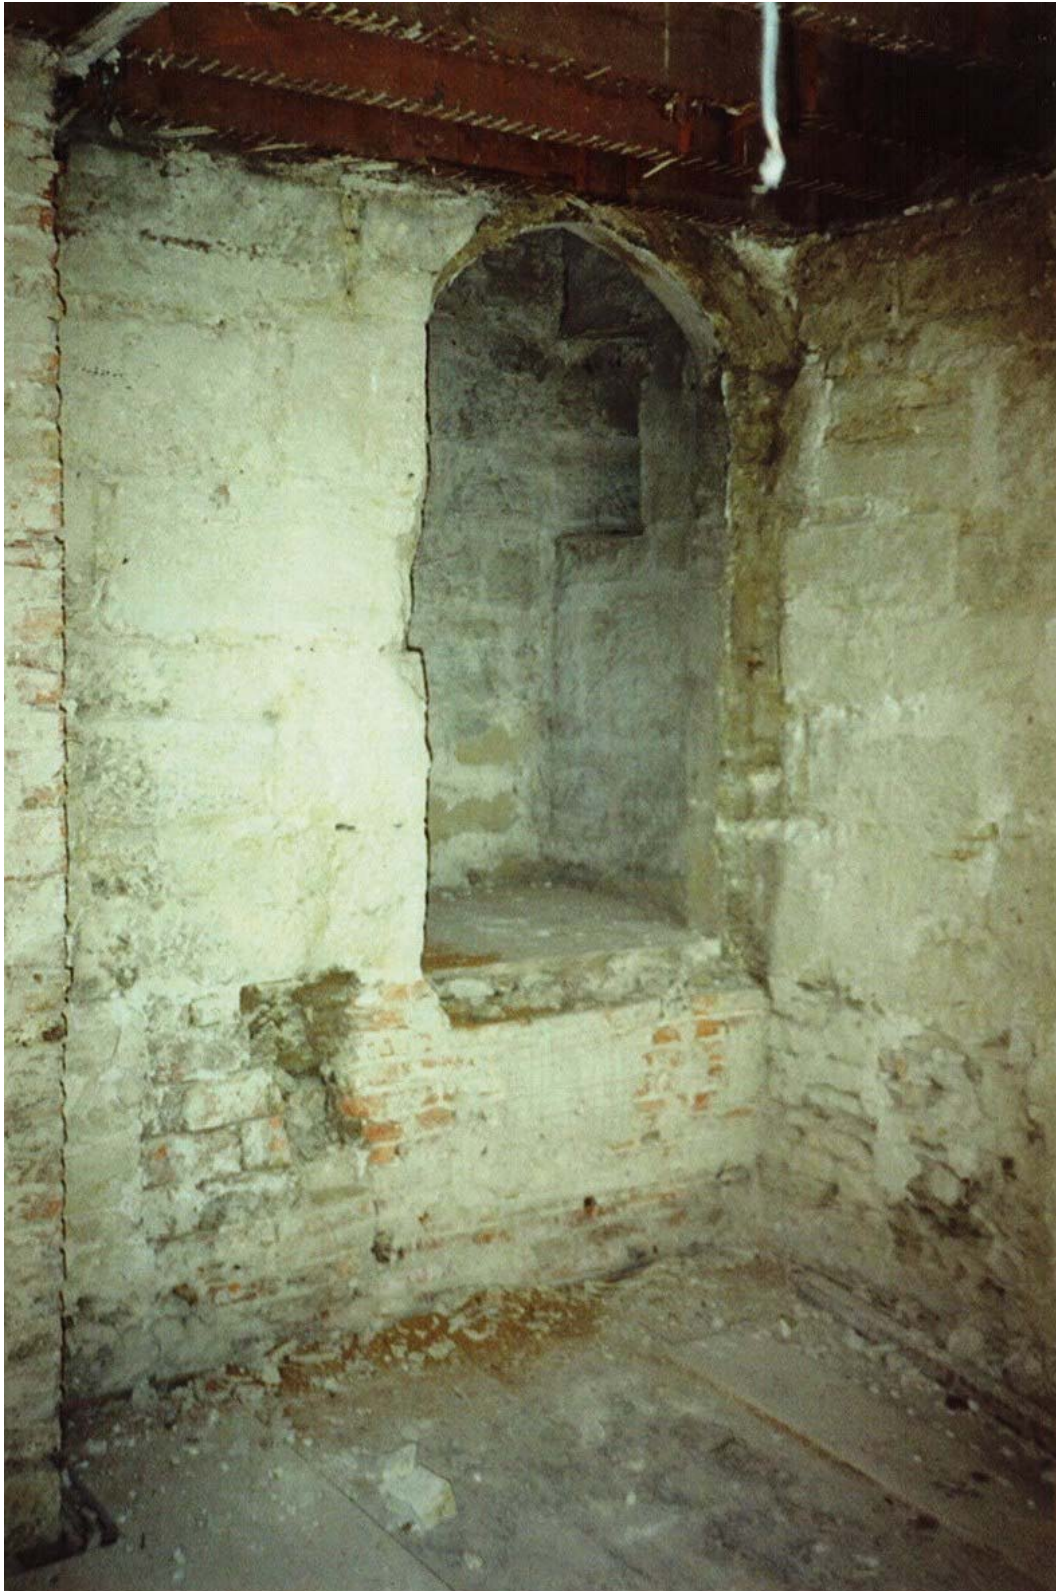
**The spiral stair doorway completely open. This is where the shoes were found hidden in the threshold.**
