The Landmark Trust

Woodsford Castle

History Album Volume I

by Charlotte Haslam
with help from Peter Bird and Nicholas Cooper

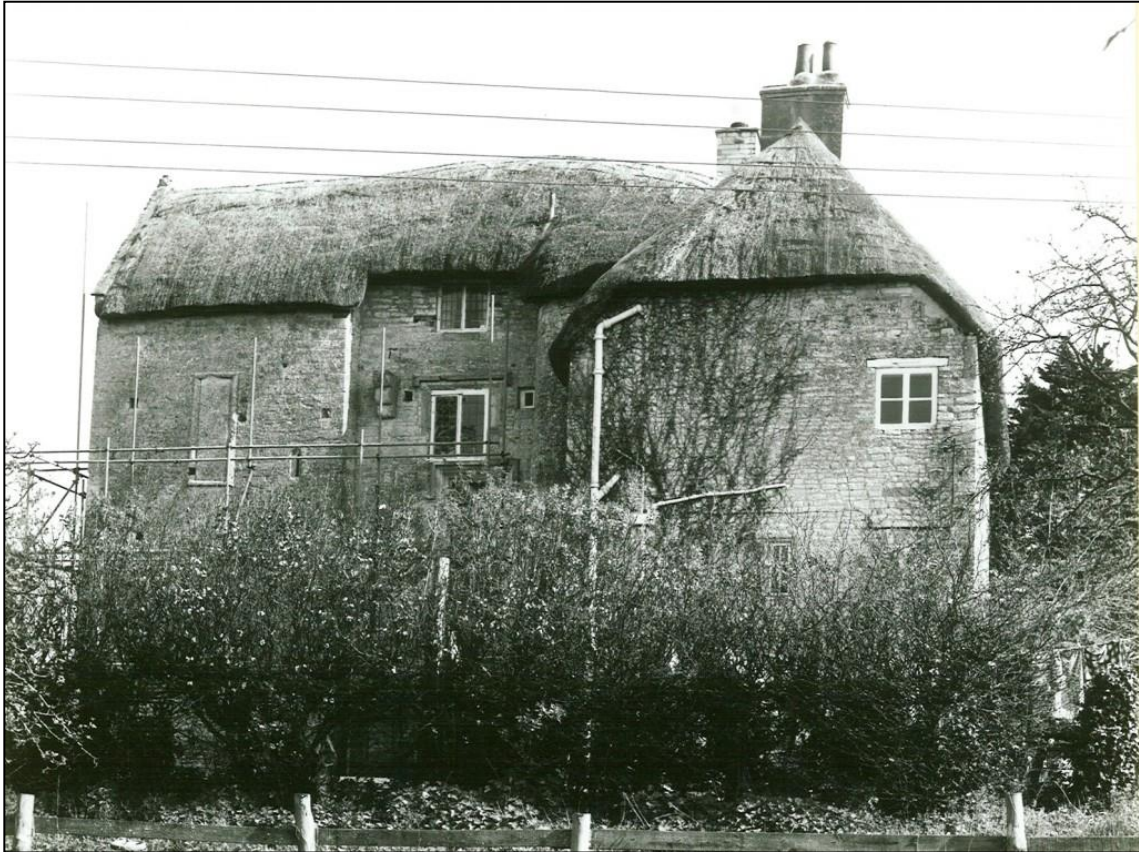
The north end in 1978. The late 18th century window beneath the 17th century drip mould can be seen resting on the head of the restored medieval window, thus weakening the wall. The retaining arch over the window has now been fully reinstated.

The north end also has a variety of windows. The plain slits on the ground floor give a clue to its vulnerability and also its inferior status. Higher up, the little slit with a cusped head in the tower is medieval, and reflects the greater importance of the first floor. This is demonstrated most clearly by the large window in the centre, obviously lighting a main room of the castle. As it now exists, it dates from 1850-1, but copies what survived of an original window in this position, which was later blocked. Above is the drip-mould of a 17th-century window, into which a casement of c.1800 was fitted, which has in turn been blocked, because it was weakening the wall.

Above this again is another window of c.1800, evidence of an attic floor inserted at this date. The window looking east in the north-west wing is similar to this last one, while those looking north have reused 17th-century stone surrounds. The door into the wing also reuses earlier masonry.

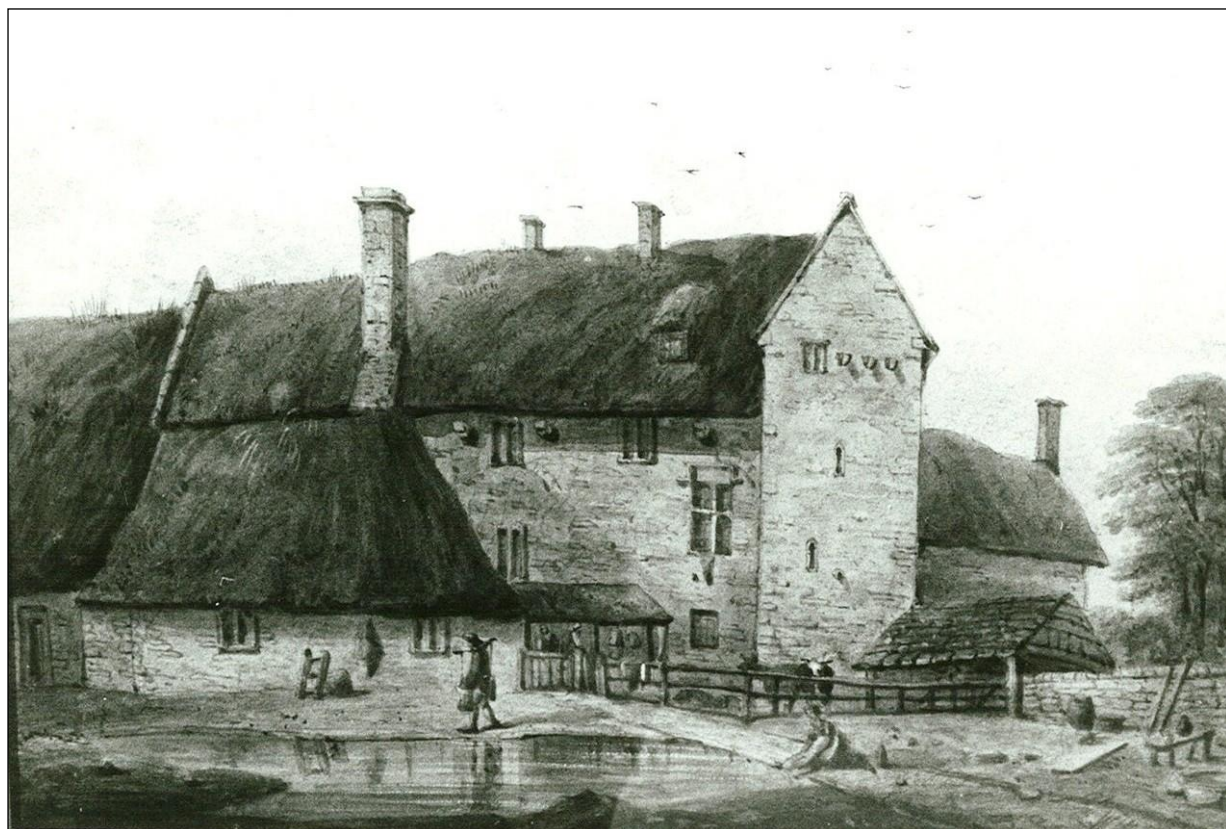
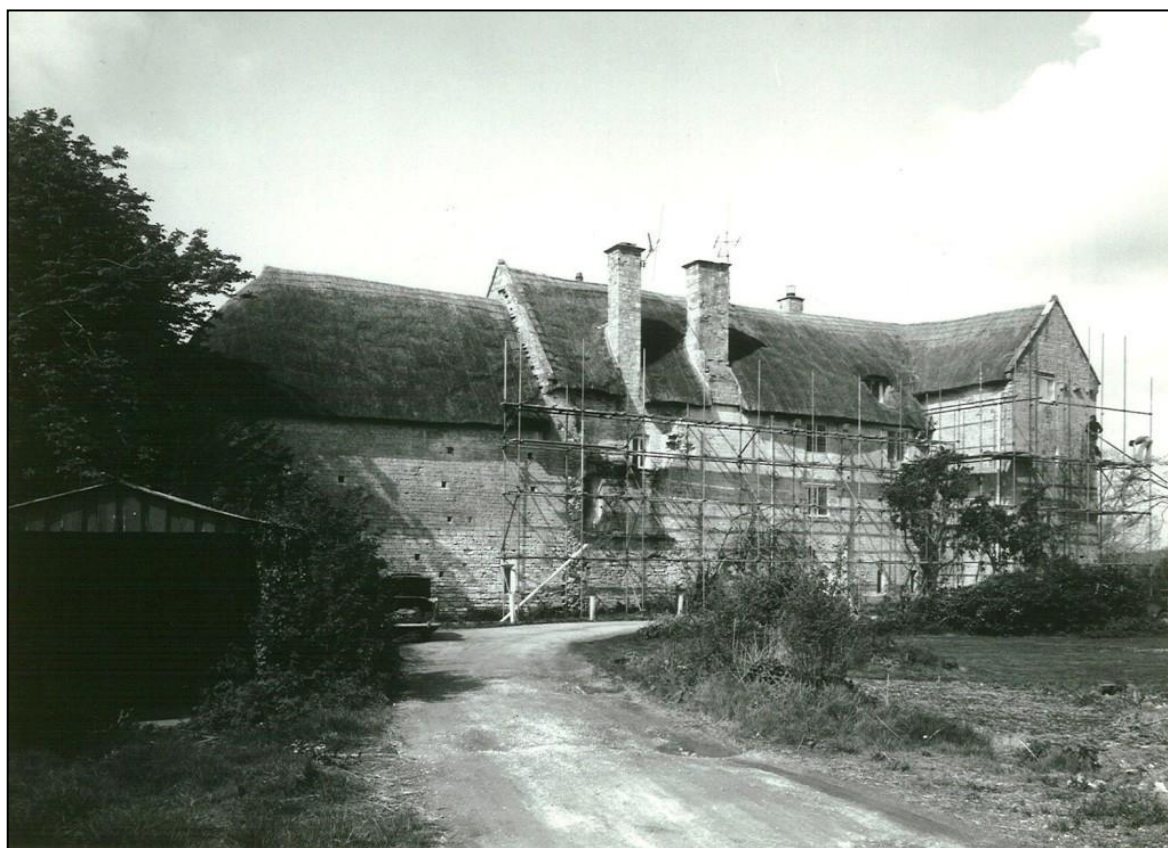
East front, as painted by W.W. Wheatley c. 1840 and photographed in 1978

Also above the chapel window are more corbels. Below is a recently blocked door. The surround of this is Victorian, but the opening probably dates from the time when the farmyard was on this side of the castle, in the 18th century or before. The last tenants, the Sherwoods, used the room inside as their kitchen and living room, but the ground floor is now left empty, so there is no need for a door on this side, where originally there was none.

Next comes the site of the east tower, and openings into it from rooms inside can be seen. It probably had rooms on three levels like the north east tower, and a stair turret in the corner. Enough of its outer wall remained in 1861 to show that it also had garderobes. It is difficult to make out how its ground floor room was reached. The whole of the space inside it is taken up by a retaining arch, but Nicholas Cooper of RCHME suggests that this relates to a post-medieval deepening of the kitchen fireplace inside, in the course of which the original door was lost.

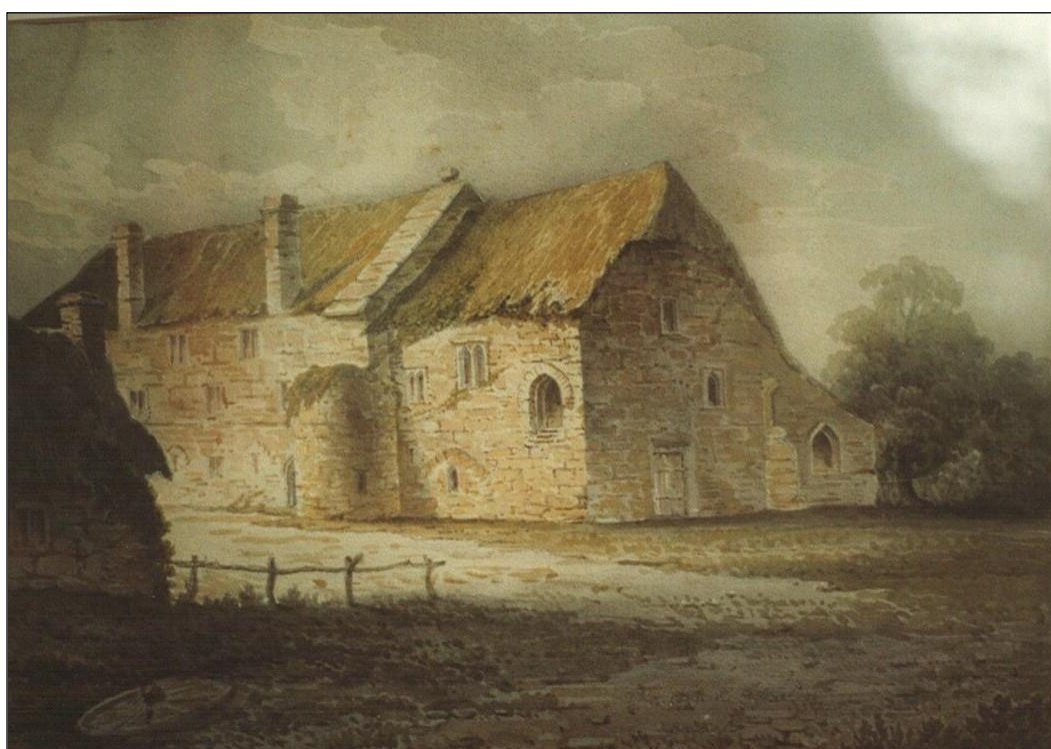
Undated watercolour, possibly pre 1790 since it seems to predate the north-west wing

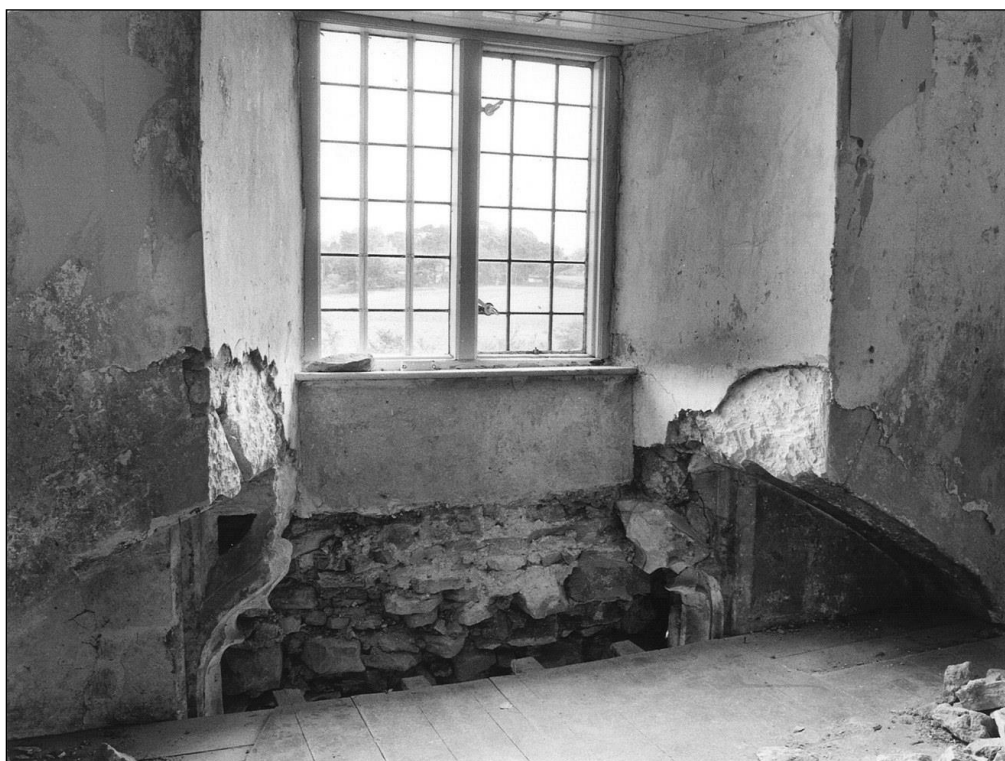
The head of the chapel window, appearing in the bedroom above.

Inside the chapel are a finely carved piscina, for the holy water; and fragments of a great east window, discovered in 1988. The rear-arch over the window spanned almost the entire chamber, but its springers were hacked back when the upper floor was inserted. A great debate followed this discovery, with the case for full reinstatement of the chapel strongly argued. However, there were equally good reasons for leaving the window as a ruin, to tell its story of the decline in the castle's fortunes. With the inserted floor, it tells us much about the practical recycling of even fine buildings before the age of academic restoration. However, as a compromise, the ceiling was cut back to leave as much as possible visible from below.

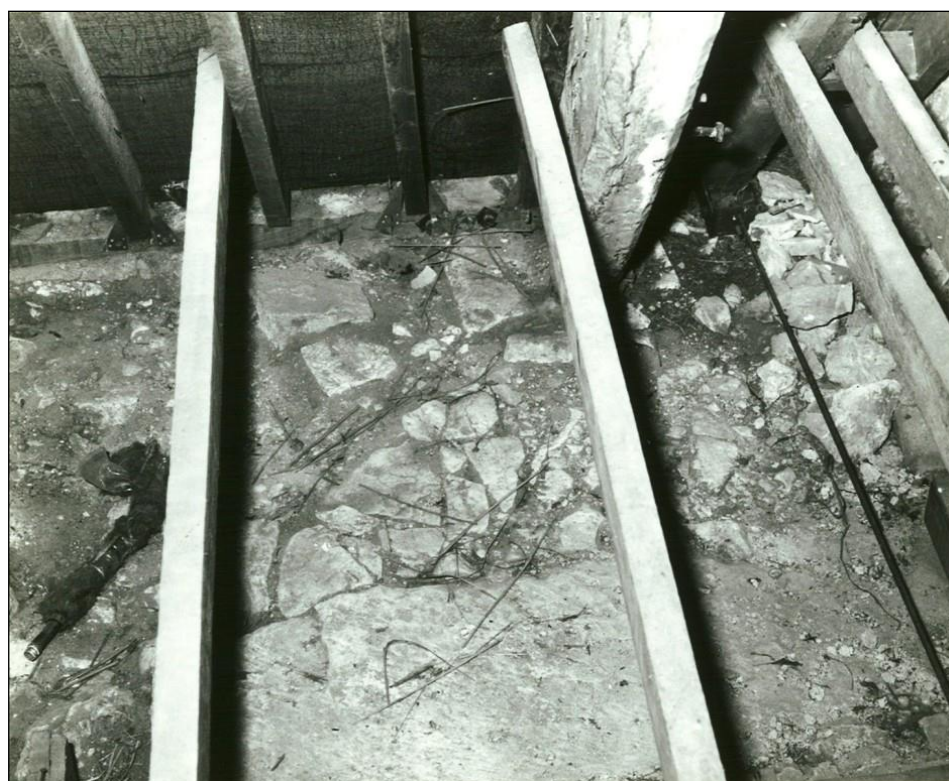
The smooth surface of the medieval wall walk, still visible on the wall head

The Castle now consists of a single long range. The steeply pitched roof is broken part of the way along by a tall gable, after which it resumes at a lower height. Once, there was a nearly flat roof, with only a low pitch, running at a single height from end to end. Hutchins, the 18th-century historian of Dorset, records a tradition that this was covered with lead. The walls were topped with battlements and in the 19th century, traces of these were seen. It is still possible to make out the surface of the original walk along the wall head.

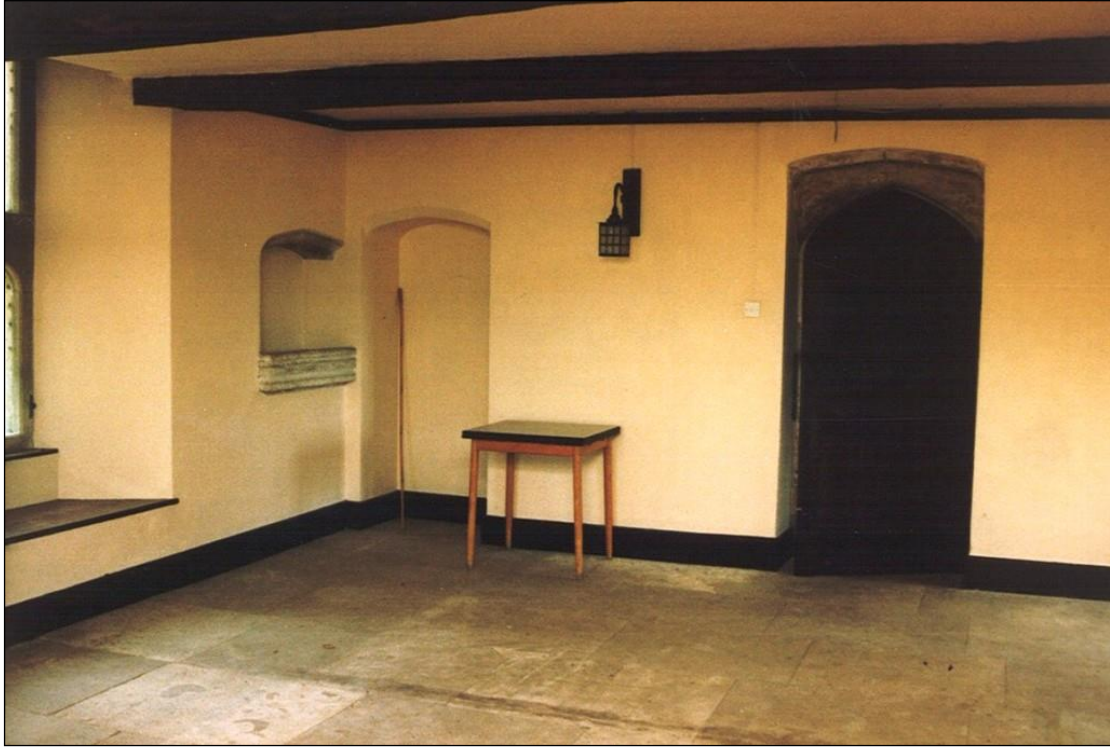
In 1987, after the Sherwoods moved out of the castle.

Turning left at the top of the steps you pass into the central chamber of the north house, its hall, known as the King's Room. This would have served a variety of uses, convivial and official. With the removal of the inserted floor, this has now returned to its original proportions, with the great oak beams and boards of its new ceiling following lines left in the walls by the medieval roof. The beams rest in original pockets, and the boards rest on a corbel table of which fragments survive. Medieval plaster survives too, and the new has been applied as thinly as possible to match it. On the old plaster are very decayed traces of painted decoration, possibly with a chequered pattern, as of masonry. For its safe preservation, it has been covered with a coat of limewash. The stone floor, and the fireplace, are Victorian.

The high end of the hall was probably at the south, nearest the chapel, with the carved basin or lavabo at one end of the high table. If the medieval fireplace was in the same position as the present, Victorian, one, it would have given heat equally to the high table and to the body of the room. As already described, the low or service entrance was probably via the door from the present kitchen, reached by outside steps.

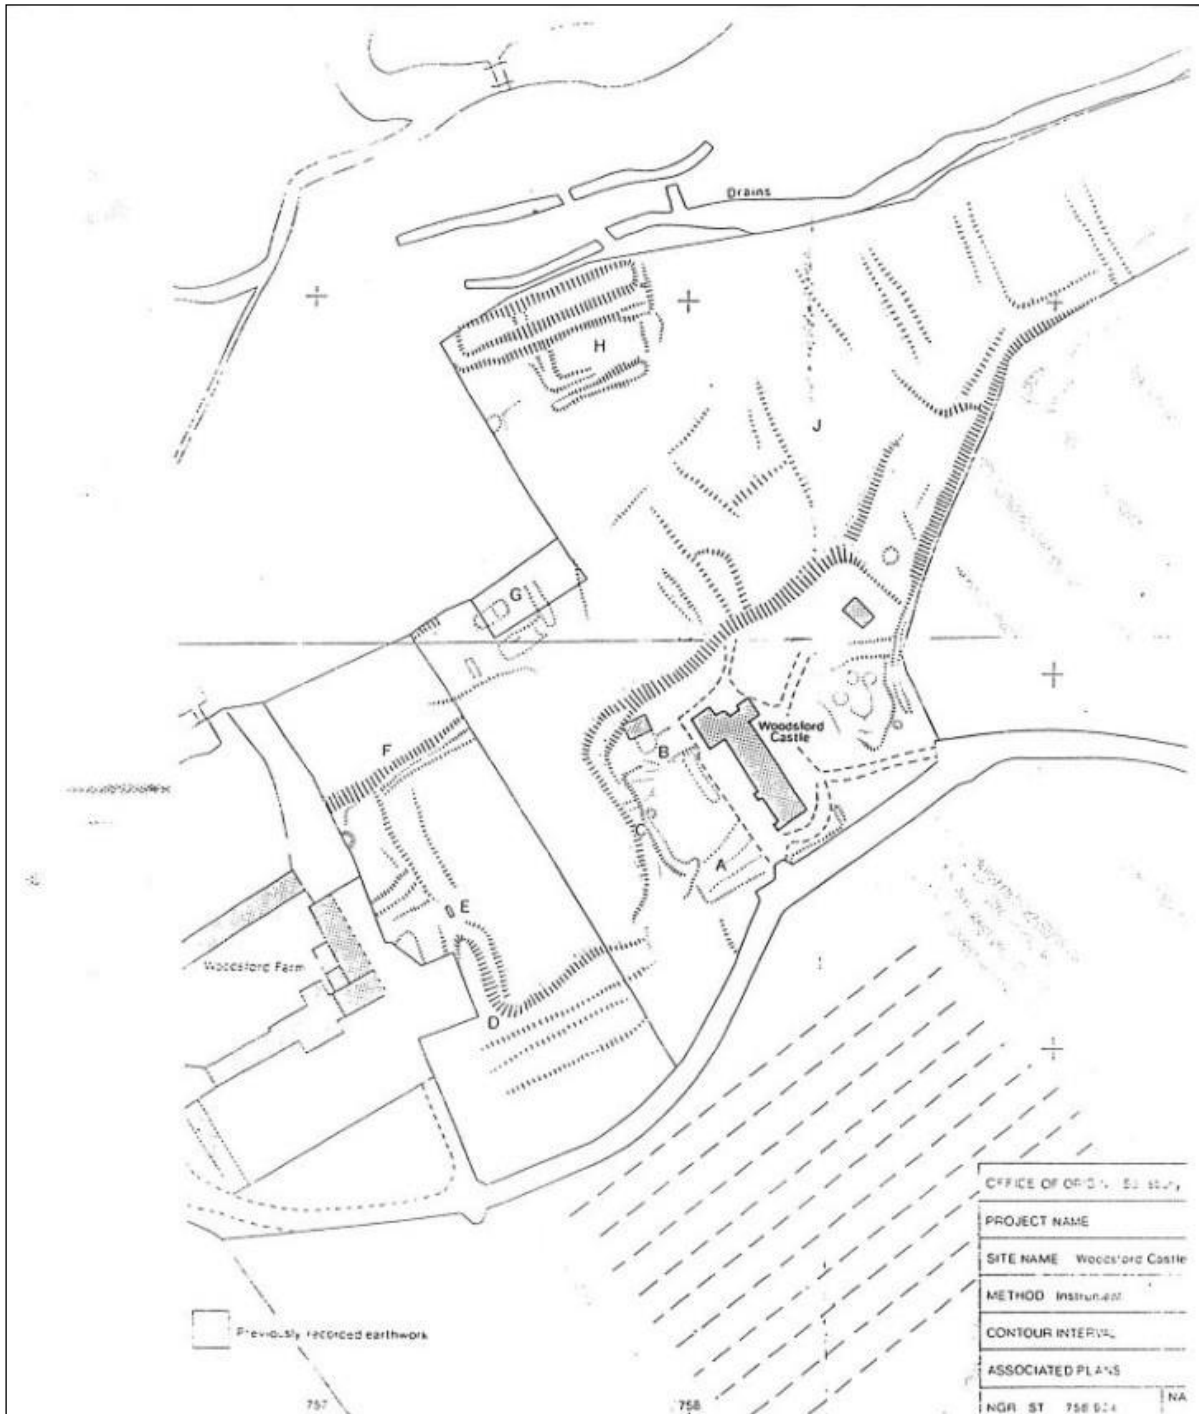
RCHME ground level survey, 1990. A,B and C represent the possible outlines of the castle, with a dip at C perhaps marking an entrance. D, E and F are the banks of an outer enclosure, with a possible entrance at E. H marks the remains of fish ponds while J is the site of the pig farm and also of banks associated with Woodsford Strangways

In 1990, while restoration was in progress, both an earthwork and a resistivity survey were carried out. The latter revealed very little, though the metalled surface of the courtyard was met with under the lawn, and the worn flint of a flintlock firearm was found, of the 1600s or later. The earthwork survey, however, did show traces of the north and south sides of an enclosure, and a much clearer bank on the west, with a gap in it which could mark the position of a gatehouse. To the west again, they detected a second enclosure, perhaps an outer bailey, also with an entrance on its western side. Another survey by the archaeological dowser, E.C.R. Fawcett, again showed a gatehouse on the west side. The gap on the north side could have been a postern opening onto the track to the ford.
