STOGURSEY CASTLE History Album

Written by Charlotte Haslam, 1987
Updated in 2010 and re-presented in 2015

BASIC DETAILS

Gatehouse built c.1300

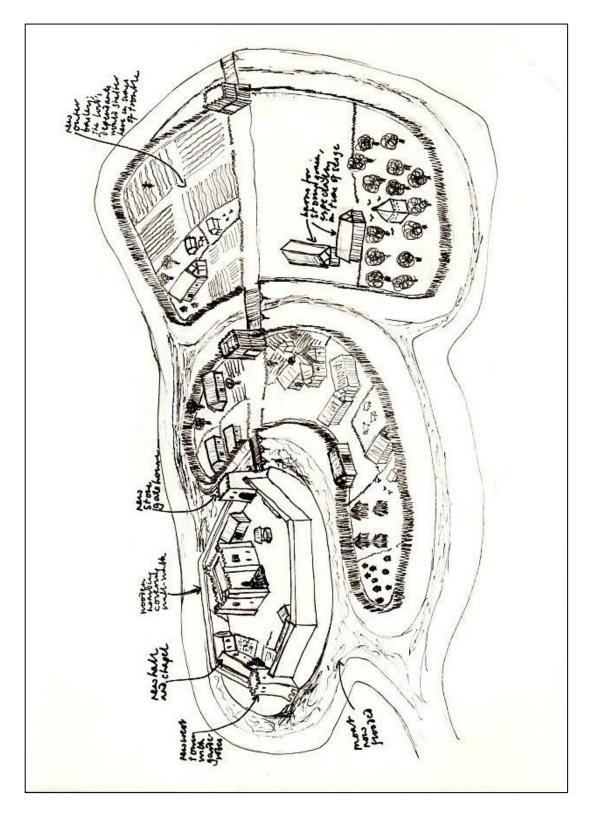
Stage Three, c.1170. Stogursey Castle at the peak of its development: the inner ward is now walled in stone; the earlier keep is still standing; two baileys are in full use.

In the later I2th century, possibly as part of Henry II's policy of consolidation, a major rebuilding took place. The stockade around the mound was replaced by stone walls. The keep remained standing, and there were other stone buildings against the curtain wall, and at least one tower, on the west side. A further tower may have defended the entrance, over a bridge on the east side. This bridge was, at least in part, built of timber. It is very possible that the leats to bring water from the Stogursey Brook to fill the moat were dug at this time, and that shortly afterwards the system was extended to provide water for a **mill**, still referred to as 'new' in 1225-30.

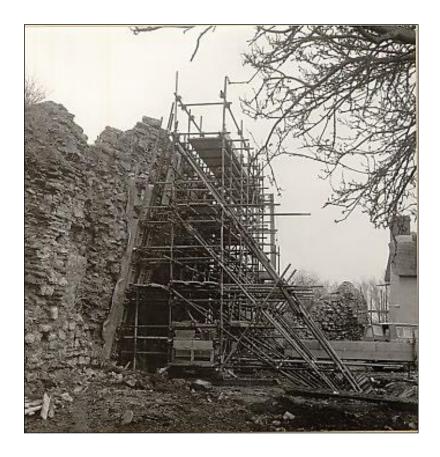
Michael Haycraft at work on the curtain wall, in all weathers..

The bulk of the work to the curtain wall, and the west tower, involved repointing and 'capping off' or repairing the wall-head, to prevent water seeping in from the top and weakening the wall further down. To do this loose stones would be removed and then rebedded in mortar. All the mortar used for repointing was to be mixed with lime and sand only; but for the capping of the wall-head some cement was included in the mix, to give it extra strength. Nearly all of this was work that could wait, and it has been carried on gradually over the last three or four years by Michael Haycraft, the mason who restored the castle on Lundy, and is also working at Woodspring Priory.

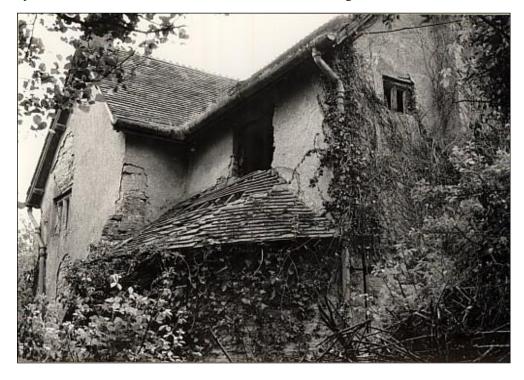
The east window-frame had been thrown into the moat, from where it was recovered, and put back after repair.

Nearly all the 17th-century oak window-frames survived (although one, from the north bedroom, had been thrown into the moat), and simply needed to be repaired and reglazed. The window over the entrance had been blocked up, but the frame was still there. The small window in the north gable was renewed. Of the 19th-century windows in the south elevation, one was repaired, and the others were renewed. One entirely new window was made to light the stairs. And once again, to distinguish 17th-century work from medieval, the leaded panes for the cottage windows are rectangular, while those for the arrow-loops of the gatehouse tower are diamond-shaped.

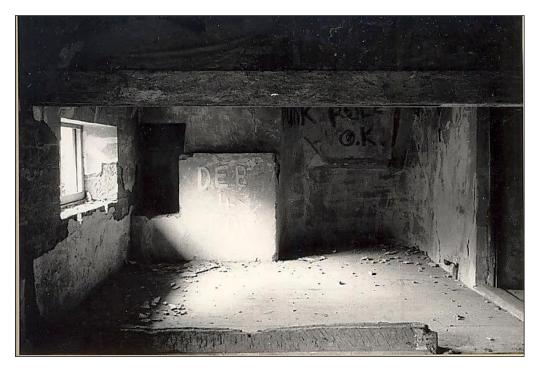
Upstairs, looking west. The bathroom is now on the left, the stairs in their original 17th-century position, on the right.

Upstairs a bathroom had to be fitted in, and a 19th-century doorway was blocked up. The ceiling was removed in the south bedroom, to show the 17th-century closed-truss, forming the partition with the bathroom. Two of the struts for this were found lying in the moat, and were put back in their proper positions. Original wattle-and-daub survived in the apex of the truss. The floorboards of both rooms were renewed, but using second-hand timber - oak in the south bedroom and pine in the north. The doors are new, and the walls were replastered. All services - e.g. electricity and plumbing - are new, and the digging of the septic tank in fact provided the archaeologists with a good opportunity to examine the structure of the mound, and establish the ground level beneath it.

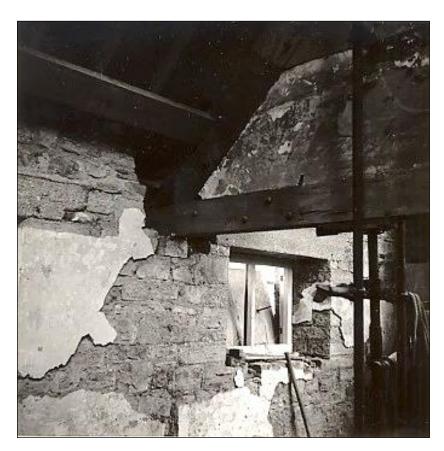
17th-century wattle and daub survived in the area of the closed truss.

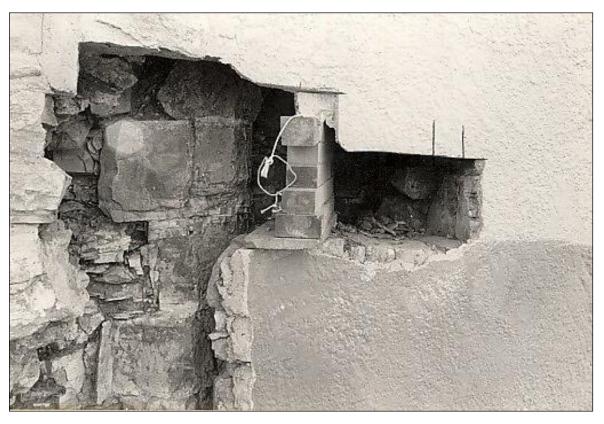
Part of the original entrance arch, found behind the east wall.

An exciting discovery was made when repairs were being carried out to the wall around the main entrance arch. When part of the wall was cut away, the outer face of a jamb and the beginning of the original entrance arch of about 1300 was revealed. It would have been very difficult to have left this exposed, since it would have meant altering the whole east wall, so it was covered up again, after it had been recorded.

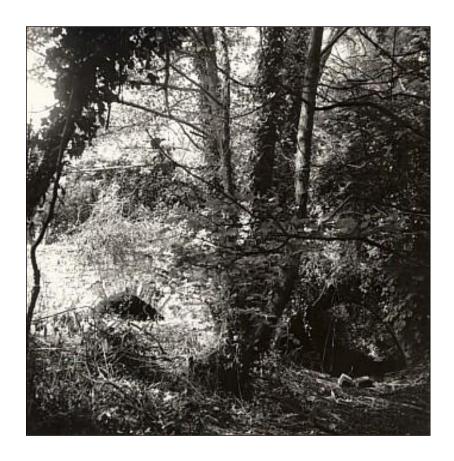
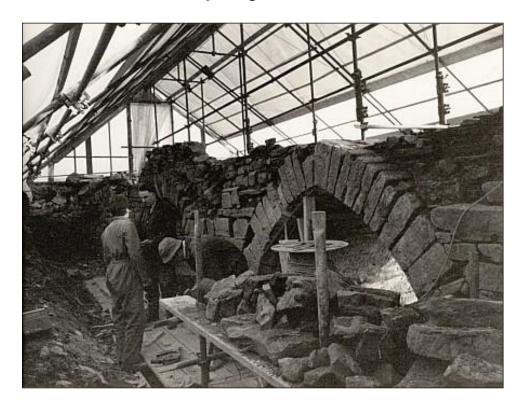
The bridge is revealed (above) and laying new paving (below).

The bridge had been repaved by the Victorians; these stones were taken off and new paving laid, nearer the original level. There was no sign of there ever having been parapets on the bridge top and the stone bridge did not, of course, meet the east face of the gatehouse; it would not have been possible to put back a true drawbridge (we do not in any case know what sort of drawbridge there was) so the gap was bridged instead with a new section made of oak.

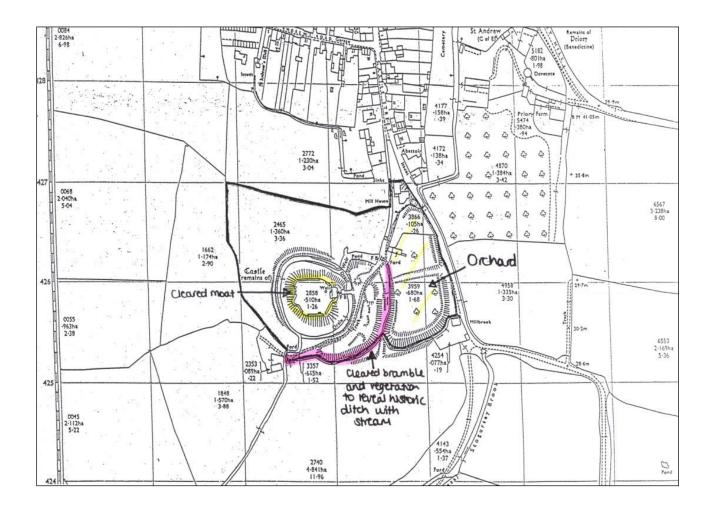
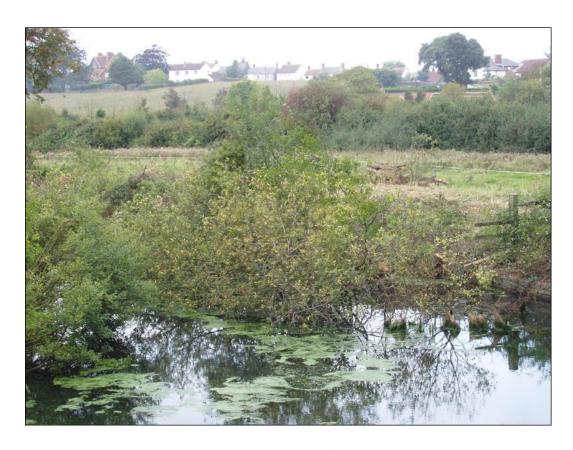
The overgrown moat before (above) and after.

Sections of the defensive ditch surrounding the land attached to the castle had become overgrown with vegetation. This was cleared in 2009 and works to tidy the orchard also began. Further phases of landscaping works including hedge-laying are planned for 2010 to restore the setting of the castle.

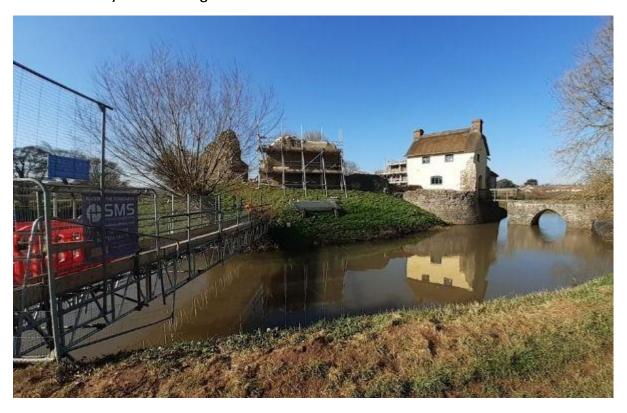
Stabilisation works underway at Stogursey in winter 2020.

Thanks to the CRF grant, we were able to progress stabilising the Grade-II* listed curtain wall of the castle. These works – which were already scheduled to take place in 2020 - are just the latest phase in our long-term programme to conserve the extremely friable local lias stone. Ongoing, preventative maintenance is always the best way to slow down such decay. Getting materials across the moat is always a challenge.
