The Landmark Trust

ASCOG HOUSE History Album

Written by Clayre Percy, edited by Charlotte Haslam Reviewed 2015

Original building	c. 1600
Acquired by Landmark	1989
Architect for repair & conversion	Stewart Tod and Partners,
	Edinburgh
Contractors	A Robertson and Co., Greenock
Work started	1990
Work interrupted	June 1991 when a fire gutted the
	house
Work completed	1993

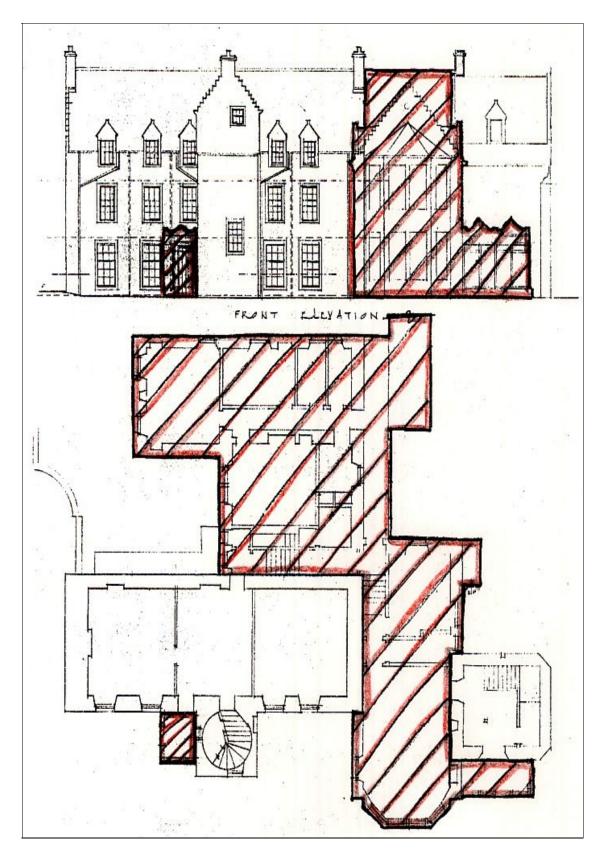
Plan of the house dated 3 February 1989 - parts of the house that have been demolished are hatched in red.

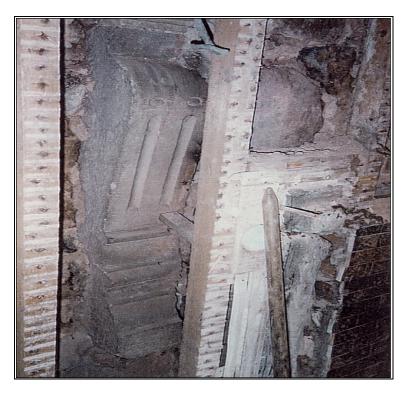
Fragment of the original great hall fireplace, found behind two later ones in the north wall.

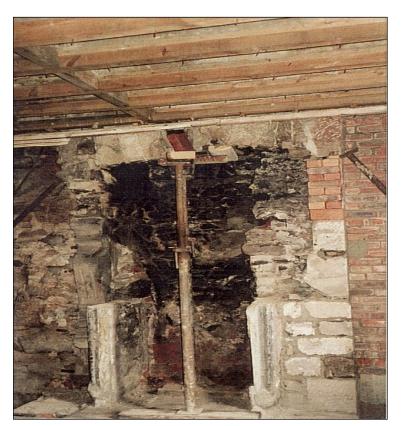
The great hall fireplace, with a later one below it, showing that the floor level was lowered, probably in the later 17th century.

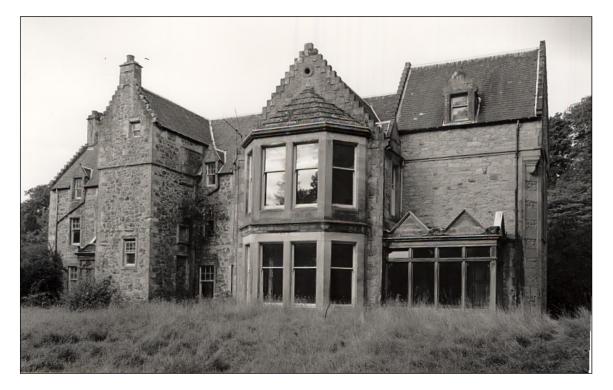
The east front in 1989, with the late Victorian additions on the right (above and below) and the mid-Victorian porch beside the stair tower and lowered ground level round the old house (below).

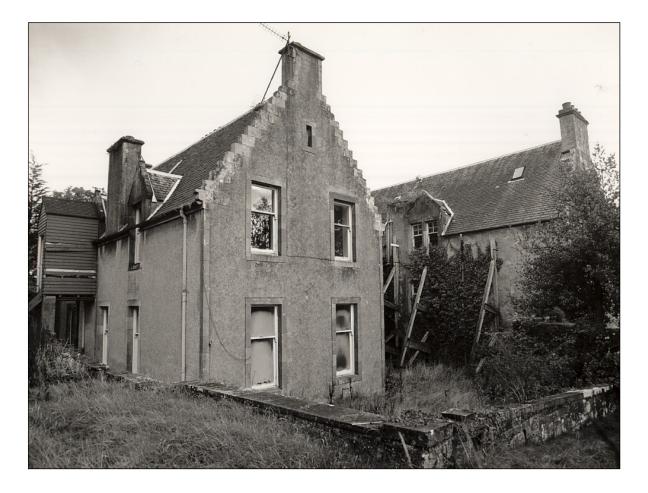
The 19th century west wing, now demolished, with the old house beyond it, its west well shored up. Photograph taken in 1989.

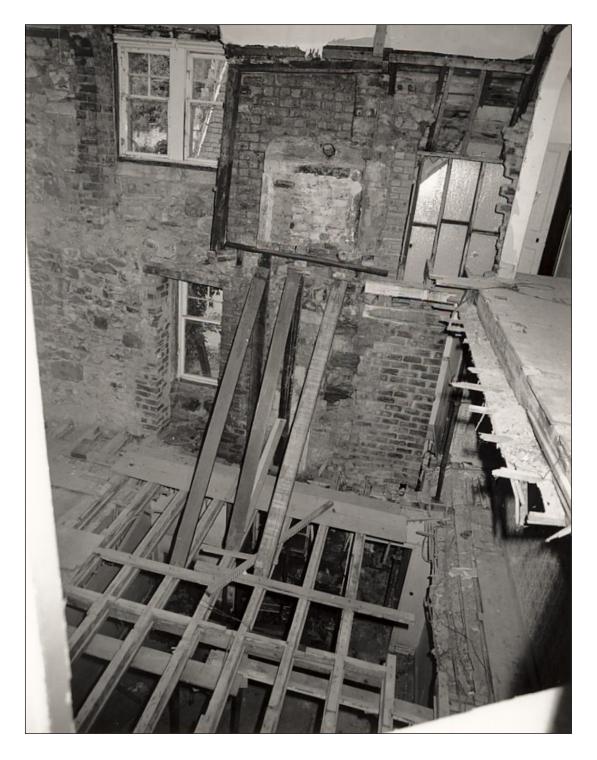
Inside the old house in 1989, looking west. The west wall was shored up inside as well as outside, and the floors had gone.

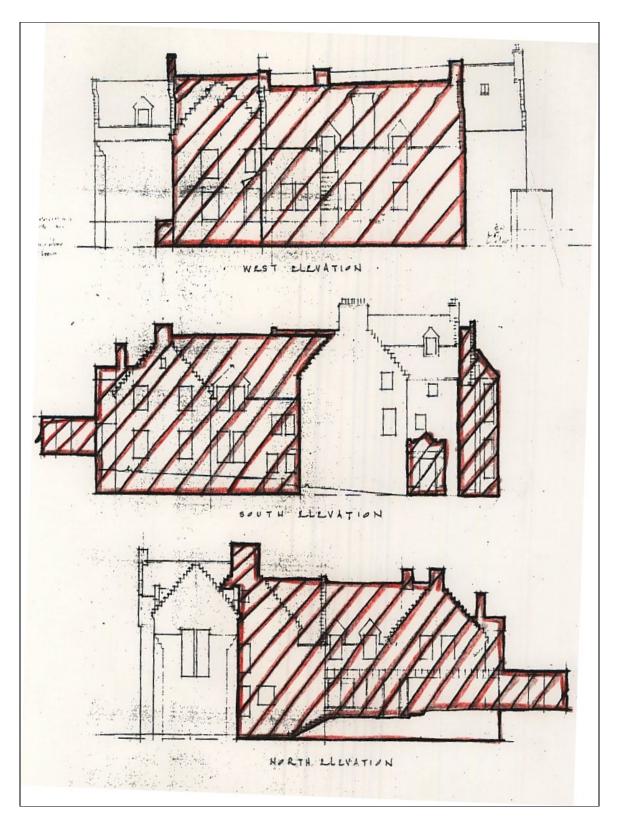
Plans dated 3 February 1989 – parts of the house that has been demolished are hatched in red.

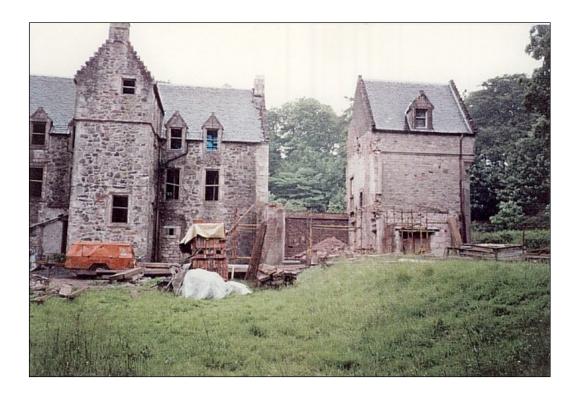
The entrance front after the demolitions. Note the lower ground level in front of the old house.

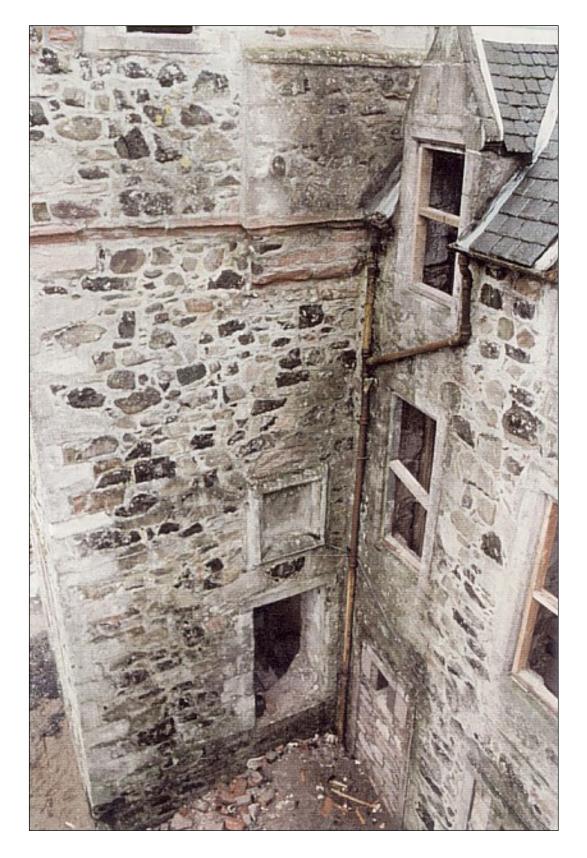
The original main entrance door in the stair turret reopened, but still stranded well above ground level.

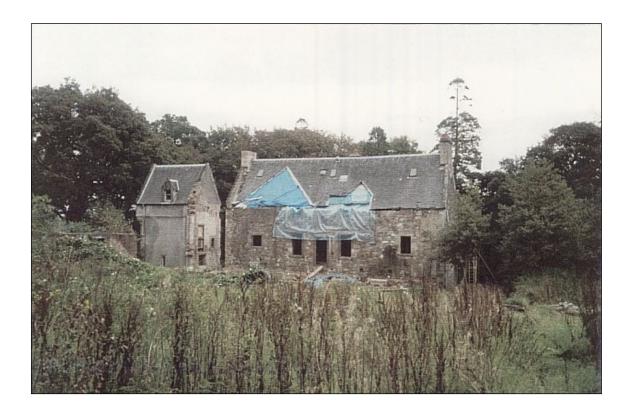
The west side remodelled, with the "discovered" windows at each end.

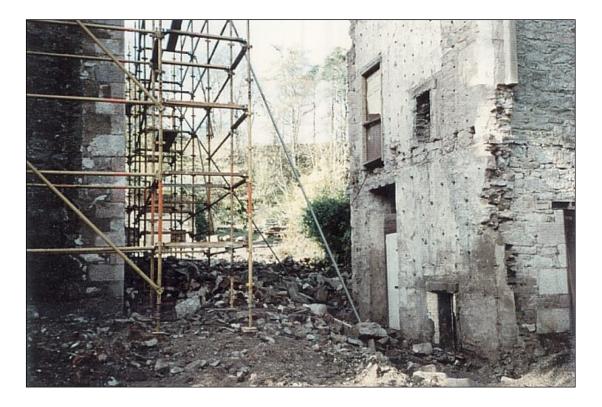
The stair tower separated, but with its south wall unfinished.

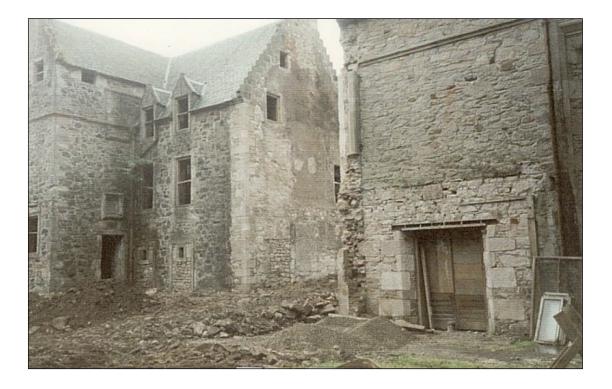
Demolitions complete. The ground is being restored to its old level.

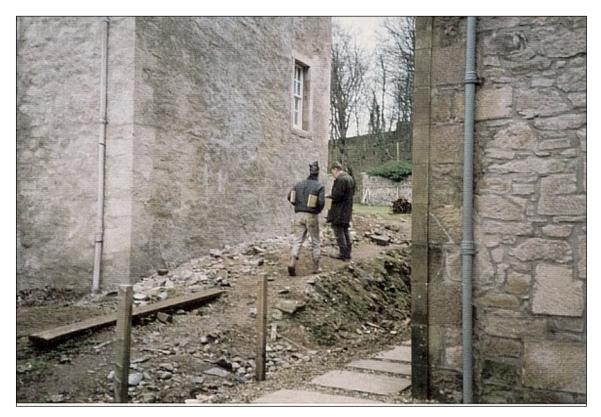
1993. The north side harled and the ground back to the original level. The ground is left low round the stair tower, which is not to be harled.

In 1993 the whole building was harled in the traditional way, with one or two coats of lime, coarse sand and small grit. The pattern of the stones shows through this first harling, but as the walls are given more coats of lime over the years, the harling thickens.

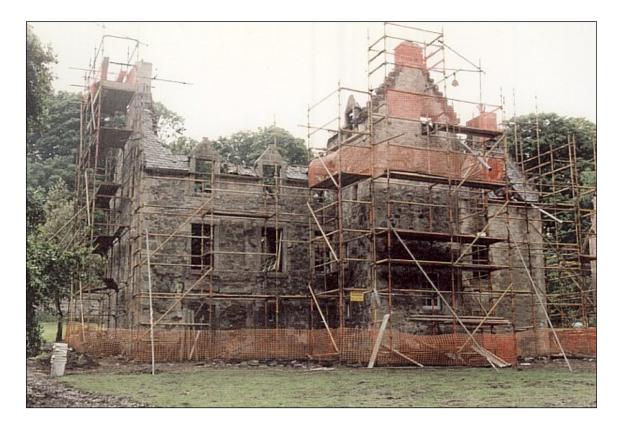
The East front after the fire in June 1991.

Then, in June 1991, when work was well advanced, the restoration suffered a severe setback. The top floor caught fire - how, no one knows. The flames were first seen from the mainland during the night, but by this time the fire had taken a hold and most of the building was gutted. The only thing to be thankful for was that because so little of the original early interior existed, hardly anything of historic or architectural interest was lost. It was a serious blow nevertheless.

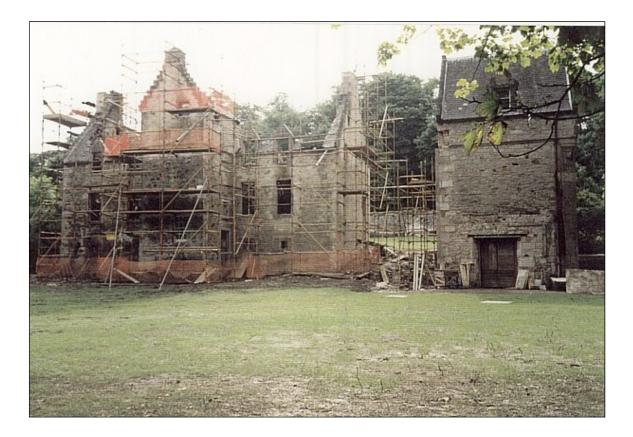
After the fire. The stair tower was untouched.

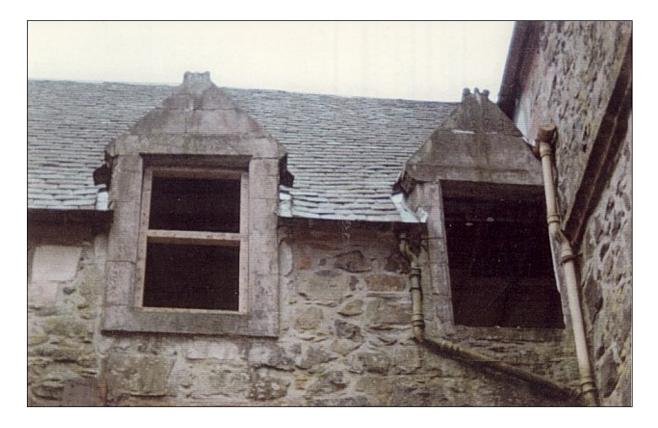
The East dormers and old drainpipes. The date is just inside on the right hand dormer.

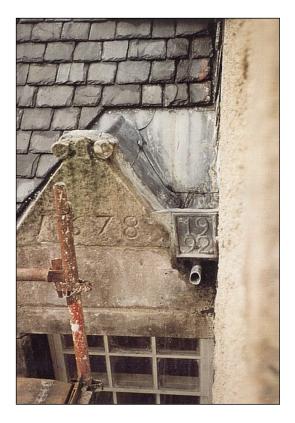
New rainwater spout – the old drainpipes have gone.

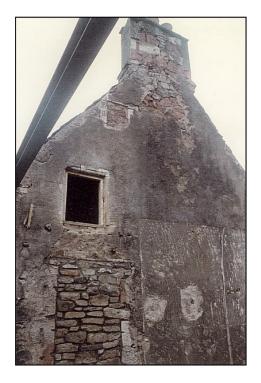
North gable without its crowsteps. They had been removed when that side was extended.

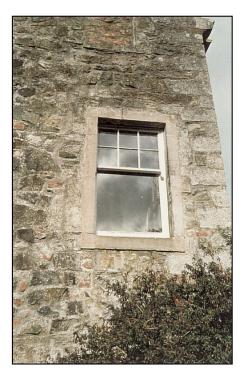
Blocked second floor window on the south end. The cracked lintel of the first floor window was repaired.

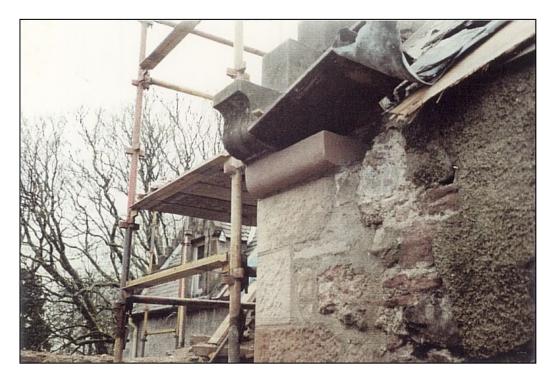
Crowsteps being put back on the North gable.

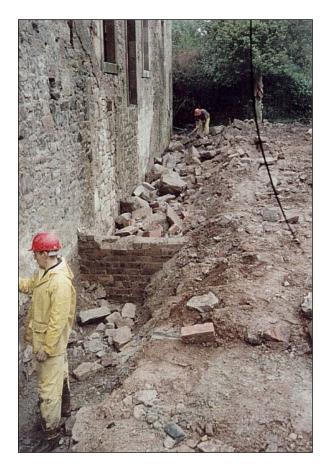
The deep trench on the west side, partly filled up. It had weakened the foundations of the west wall, but is now restored to its proper level.

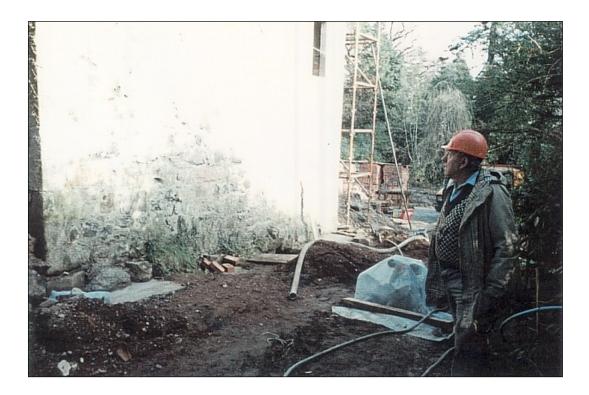
The south wall, where the foundation stones were showing.

Walking round the house clockwise, the south end has a new window on the top floor, but it uses the lintel of a window that was in the same place before. The ground level had not been lowered so much here, except at the right hand, west, end, where the foundations were exposed. It is now once again at its true gradient.

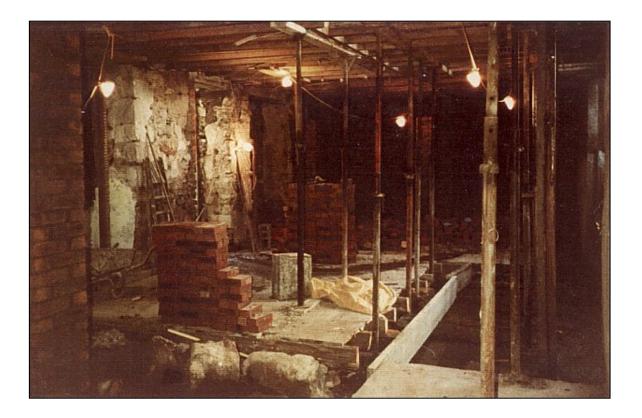
Holding the building up while work starts.

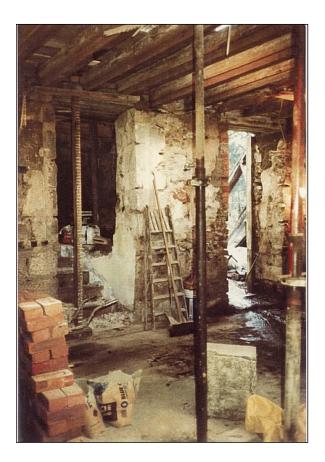
The basement with the 19th century front door on the right. Stairs up to the original (and present) front door on the left. They were full of dry rot.

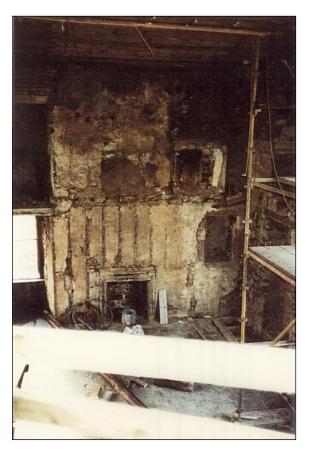
The South end with the Victorian plaster stripped off, to reveal the earlier fireplace and aumbrey on the main floor.

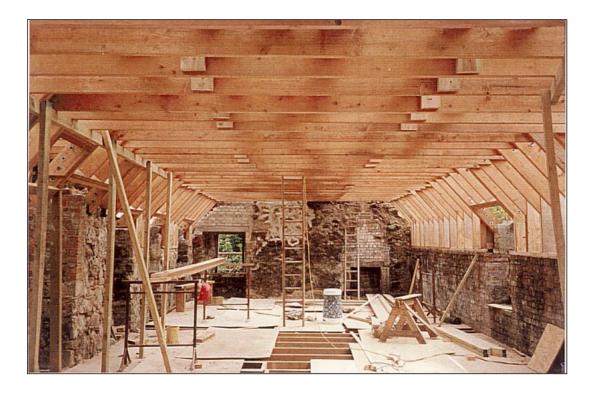
Bedroom floor looking South, showing the new roof structure, copied from the old timbers destroyed in the fire.

In the first phase of repair, the Victorian roof had simply been repaired, but after the fire, the roof structure had to be completely renewed. The covering is of second hand Scottish slate.

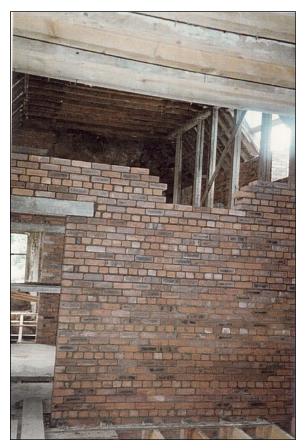
New structural brick walls tying the front and back of the building together.

The walls with arches on the top or first floor line up with those on the two floors below and, being brick rather than timber, help to hold the house together. The 18th century fireplace in the south bedroom was behind the plasterwork; it had lost its top, which has been replaced. In the north bedroom, the corbel in the cupboard is unexplained. Perhaps there was a fireplace there.

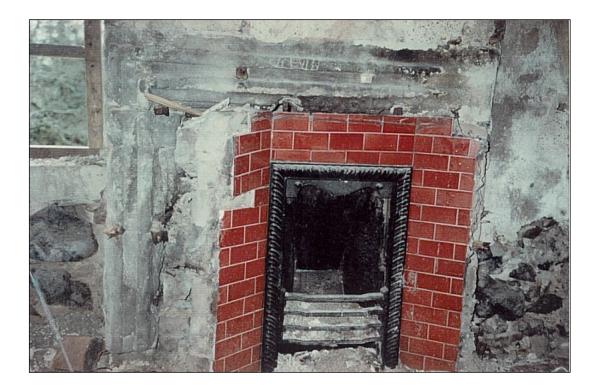
The Victorian fireplace which was in front of the older one in the caphouse, which has now been repaired.

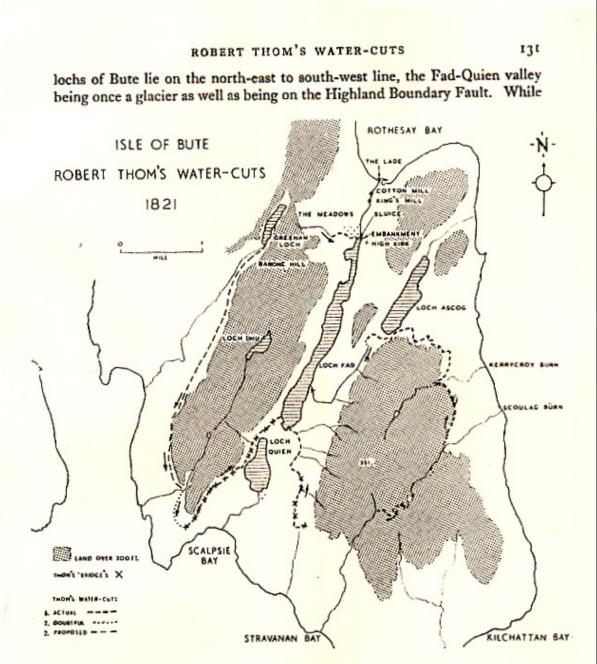
Thom's problem was to increase the flow of water into Loch Fad and as he, perforce, had to find his answer in relation to the topography, so a knowledge of the layout of the island helps us to understand his work (Fig. 1). The

Lochs Fad and Ascog drain towards the north the remaining lochs drain to the south. There is a watershed between Lochs Fad and Quien, and an aqueduct approaching Loch Fad from the south-west must be kept at a sufficient height on the Quien Hill to clear the watershed. Likewise there

is a watershed between Lochs Fad and Ascog which must be cleared by an aqueduct approaching Loch Fad from the north-east. It should also be noted that, in contrast to the north and south drainage from the lochs, the drainage of the extensive area of moorland, rising to 300 feet and crossed by the old Moor Road from Rothesay to Kingarth, is arranged on a radial pattern.
